# SERVICE CAMPAIGN BULLETIN

NTB13-098

## VOLUNTARY SERVICE CAMPAIGN 2013 LEAF PDM SOFTWARE UPDATE

**CAMPAIGN ID #:** P3259

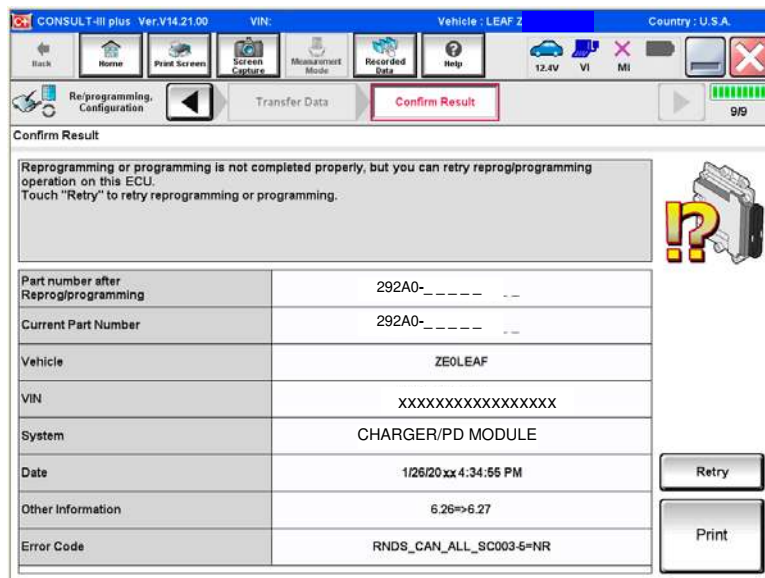
Figure 17

**NOTE:** If reprogramming does not complete and the **!?** displays as shown in Figure 17:

- Check battery voltage (12.0 - 13.5V).
- Ignition is ON, Ready Mode is OFF.
- External Bluetooth® devices are OFF.
- All electrical loads are OFF.
- **Select Retry and follow the on screen instructions.**
- Retry may not go through on the first attempt and can be selected more than once.

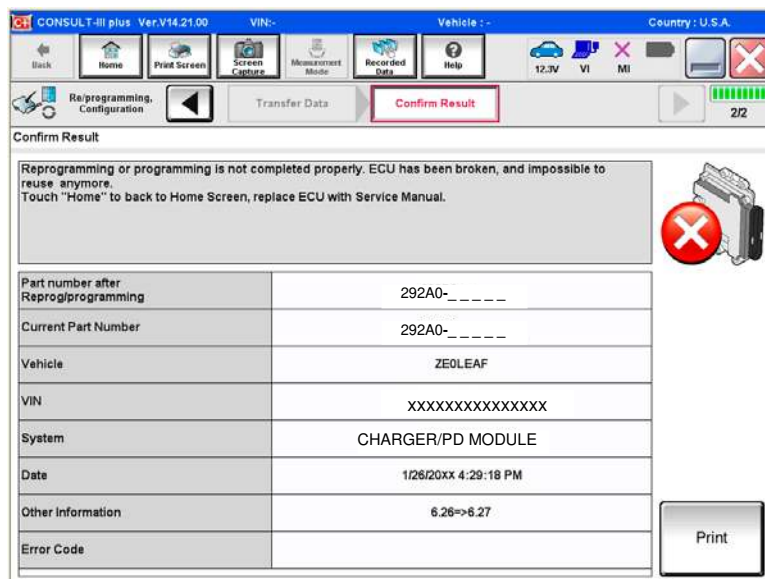
Figure 18

**OR:** If reprogramming does not complete and the **X** displays as shown in Figure 18:

**Do not disconnect plus VI or shut down Consult III plus if reprogramming does not complete.**

- Check battery voltage (12.0 - 13.5V).
- CONSULT A/C adapter is plugged in.
- Ignition is ON, Ready Mode is OFF.
- Transmission in Park.
- All C-III plus / plus VI cables are securely connected.
- All C-III plus updates are installed.
- **Select Home, and then restart the reprogram procedure from the beginning.**
