## SERVICE BULLETIN

EC14-001

February 4, 2014

### 2013 NV200; MIL ON WITH DTC P0456

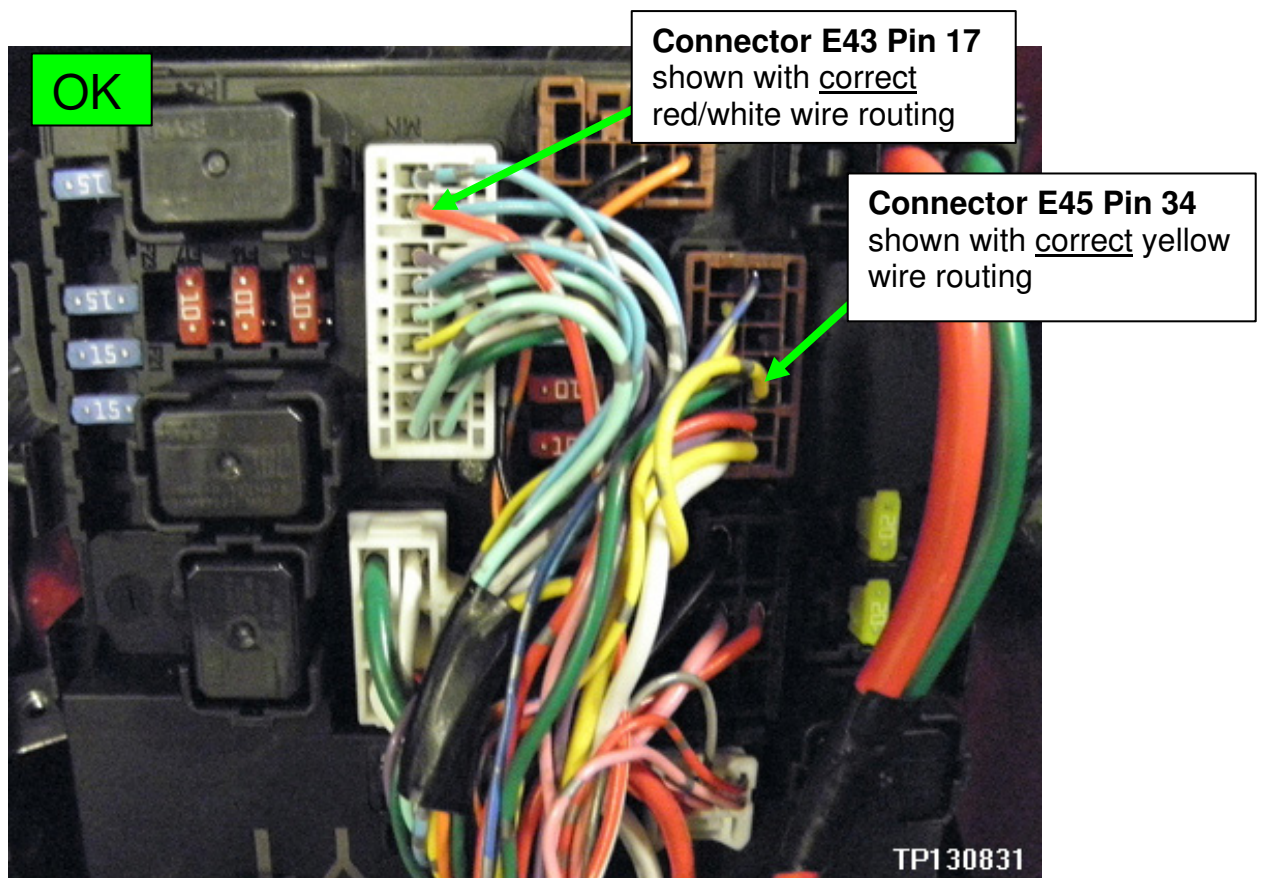
Figure 1

1. Turn the ignition OFF.
2. Remove the cover from the IPDM.
3. Inspect harness connectors shown in Figure 1.
  - Connector E43 pin 17, wire should be Red with White strip.
  - Connector E45 pin 34, wire should be Yellow.

**NG:** If harness connectors E43 pin 17 is yellow, and E45 pin 34 is red/white, proceed to **Harness Repair** on the next page.
