## SERVICE BULLETIN

AT13-021

### 2014 ROGUE; MIL ON WITH DTC P2765, P0500, P1574, P1715 OR P0720

**APPLIED VEHICLES:** 2014 Rogue (T32)

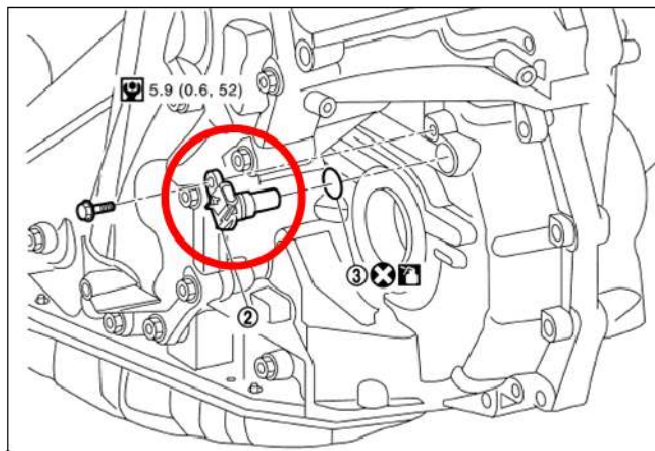
Figure 1

- Moisture and/or corrosion is present on or around the Secondary Speed Sensor pins.

- a. Remove the moisture from the Harness connector with CRC QD (or equivalent) electric cleaner.
- b. Replace Secondary Speed Sensor shown in Figure 1.
