EC13-016a

ITB13-053a

July 18, 2014

## 2011 – 2012 QX56; MIL “ON” WITH DTC P0420 AND/OR P0430

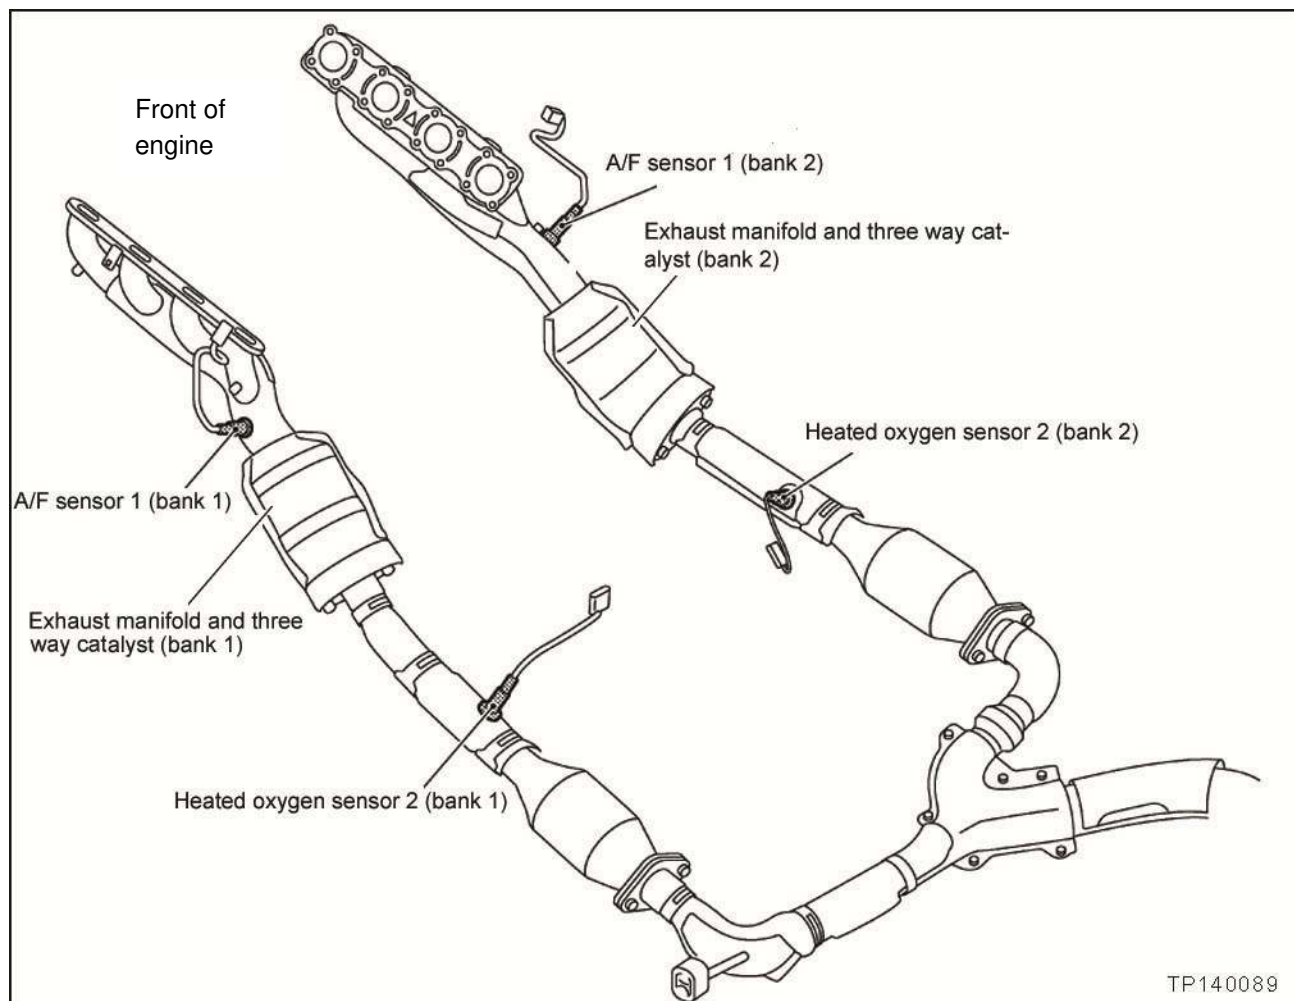
Figure 8

MIL “ON” with DTC P0420 and/or P0430 (Three Way Catalyst Function),

19. Replace the three way catalyst and A/F sensor as follows:

- If DTC P0420 is stored, replace Bank 1 exhaust manifold and three way catalyst, and A/F sensor
- If DTC P0430 is stored, replace Bank 2 exhaust manifold and three way catalyst, and AF sensor.
- Refer to the Electronic Service Manual (ESM), Section EM-Engine Mechanical, for replacement information.
