## SERVICE BULLETIN

TF15-001

### 2013 – 2014 PATHFINDER 4WD ERROR DISPLAYED AND DTC C1204 STORED

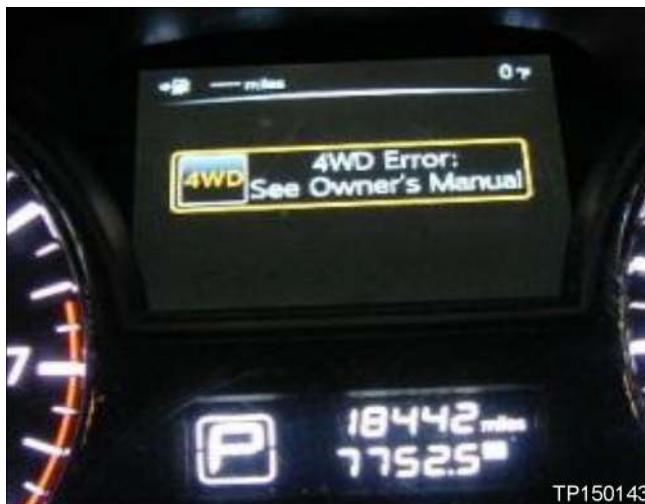
Figure 1

The vehicle has been operated in cold weather, below approximately  $-18^{\circ}\text{C}$  ( $0^{\circ}\text{F}$ ),

4WD ERROR is displayed in the Vehicle Information Display.

DTC C1204 (4WD Solenoid) is stored.

Replace the 4WD Control Unit with the one listed in the Parts Information of this bulletin.
