BR14-006a

ITB14-051a

July 29, 2015

## JX35, QX60, AND Q50; FCW MALFUNCTION AND DTC C1A27 STORED

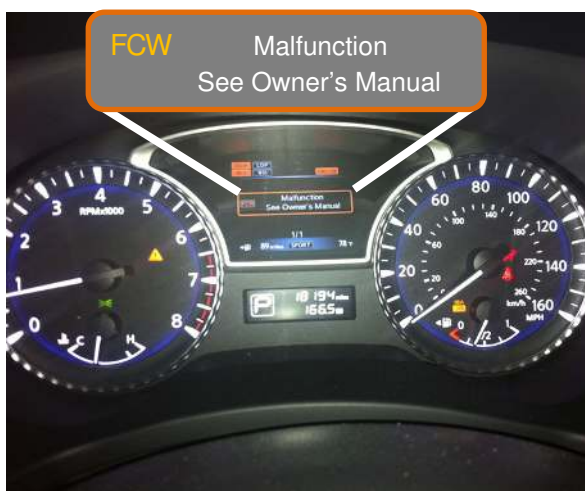
Figure A: JX35/QX60 combination meter

- The FCW (Forward Collision Warning) malfunction is ON or reported to have been ON, and
- DTC C1A27 (ECD POWER SUPPLY CIRCUIT) is stored (Past or Current), and
- The brake fluid level is normal.

NOTE: C1A27 is an ICC (Intelligent Cruise Control) DTC.

Reprogram the ABS control unit (ABS) per the Service Procedure in this bulletin.

- Part of the Service Procedure, step 20 on page 8, is a confirmation that reprogramming is needed to resolve the incident shown in Figure A and B on page 1.
