# Technical Service Bulletin

**19 Red coolant warning lamp on, DTCs P218100, P017B00, P017C00, and/or P017E00 are stored in the ECM**

19 21 16 2062951/1 May 3, 2021.

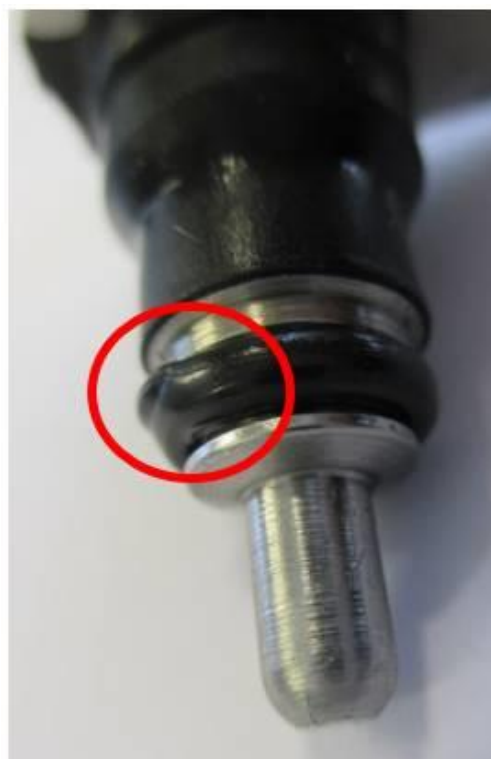
Damage to the O-ring of the temperature sensor can cause water intrusion inside the plastic housing of the coolant temperature sender G407 (cylinder head temperature sensor). The moisture can damage the sensor element. The loss of function can be sporadic.

1. Work through Guided Fault Finding.
2. It is very important to also check whether the O-ring located directly on the tip of the coolant temperature sender G407 is visibly damaged and/or pinched (Figure 1).

**Figure 1.** O-ring is pinched.

3. Replace the G407 if it is damaged and/or pinched.
