# Technical Service Bulletin

**26 Noises are heard from the exhaust at idle, DTCs P047600, P048C00, P04A000, or P301B00 are stored in the ECM**

26 21 45 2058998/3 May 18, 2021. Supersedes Technical Service Bulletin Group 26 number 21-44 dated February 1, 2021 for reasons listed below.

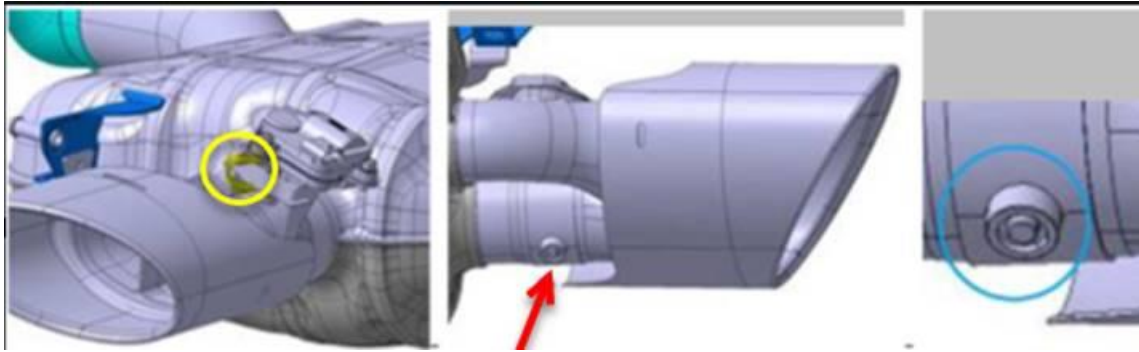
**Figure 2.** Old rear silencer.

- A. Old version (Figure 2): C-bracket (marked yellow) and moveable bearing (blue). **It is not compatible with an optimized control motor.** The complete rear silencer has to be replaced.

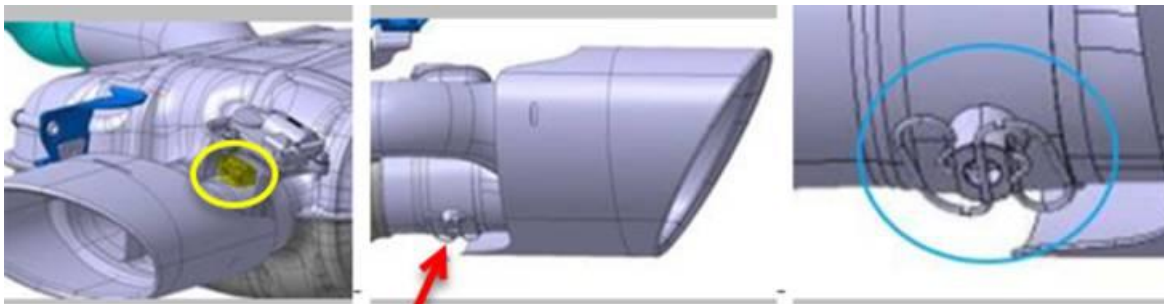
**Figure 3.** The optimized version of the rear silencer.

- B. Optimized version (Figure 3): claw coupling (marked yellow) with spring lock (blue). Check which version of the control motor is fitted: If the control motor fitted is not the new version (part number 8S0 133 246 D), replace it individually on the exhaust flap with the concern.
