# Technical Service Bulletin

## 93 "Electrical system: Malfunction! Safely turn off vehicle" is in the cluster, DTC P0AC000 is stored in battery module

93 21 51 2059309/4 May 26, 2021. Supersedes Technical Service Bulletin Group 93 number 20-34 dated September 18, 2020 for reasons listed below.

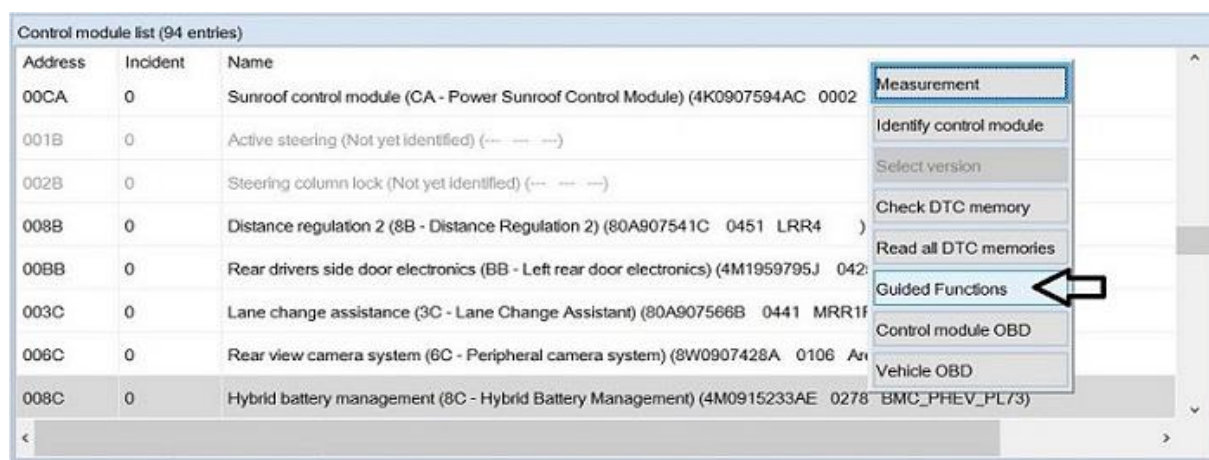
**Figure 2.** Guided Functions.

1. To obtain the data we need to use the diagnostic scan tool then right-click and select the hybrid battery management module, J840 (address word 008C), and select “Guided Functions” (Figure 2).

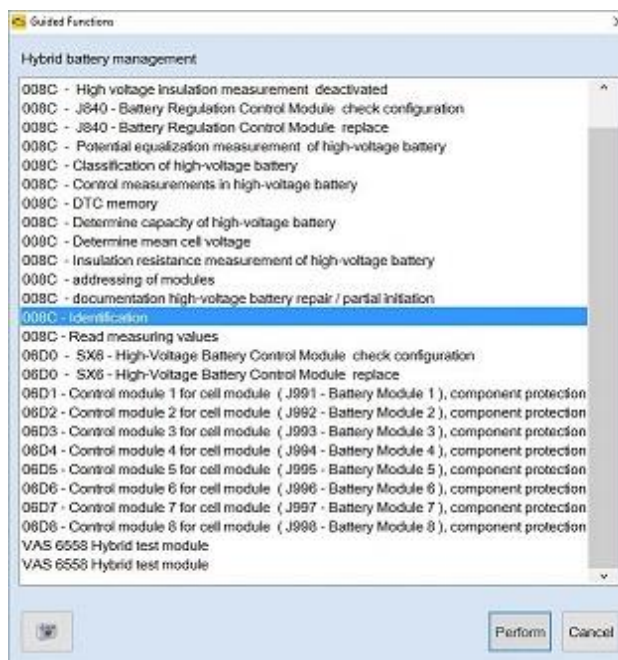
**Figure 3.** Guided Functions Menu.

2. In the Guided Functions menu select 008C – Identification and click “Perform” (Figure 3).

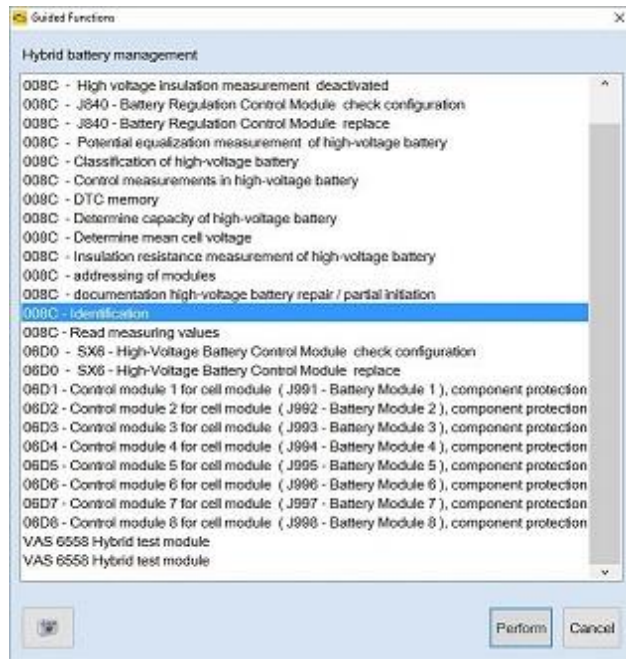
**Figure 4.** Identification data, Hybrid Battery Management module.

3. The Identification data of the hybrid battery management module, J840 (address word 008C) is now displayed (Figure 4). Write down the Software part number, Software Version number, Hardware part number, and Hardware version number, as this information will be needed in the following steps. After you have saved the data for later, answer yes to the question “Do you still want additional identification data?”
