**01-18-13 - MIL ON DTC P0401 Exhaust Gas Recirculation Flow  
Insufficient**

Release date: 6/29/2021

High soot loads prior to regeneration can cause possible restrictions in the Exhaust Gas Recirculation (EGR) filter.

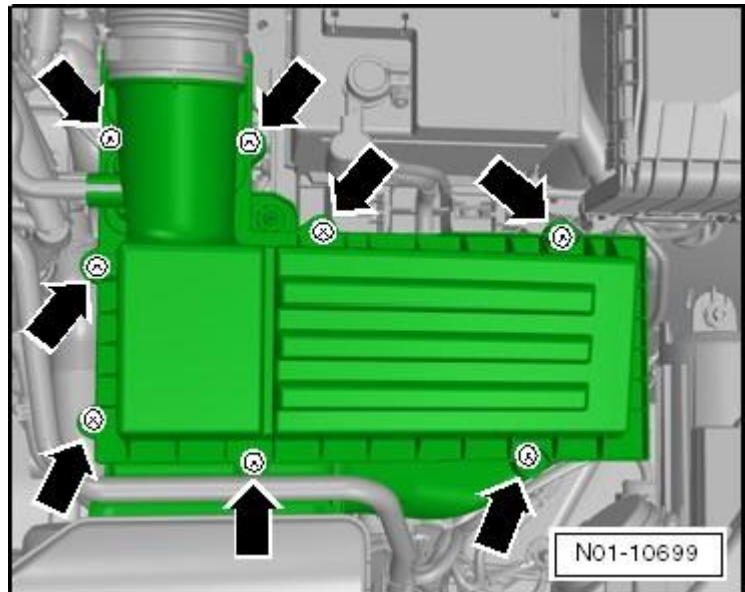
- Raise air filter upper section and remove airfilter element -1-.  
Inspect air filter and if too contaminated with debris, advise customer to replace (non-warranty claimable item).
