# Service Alert

i-ACTIVSENSE WARNING AND SBS INDICATOR LIGHTS ON  
WITH DTC B14F9:00 STORED UNDER HOT WEATHER  
CONDITIONS

Service Alert No.: SA-039/21

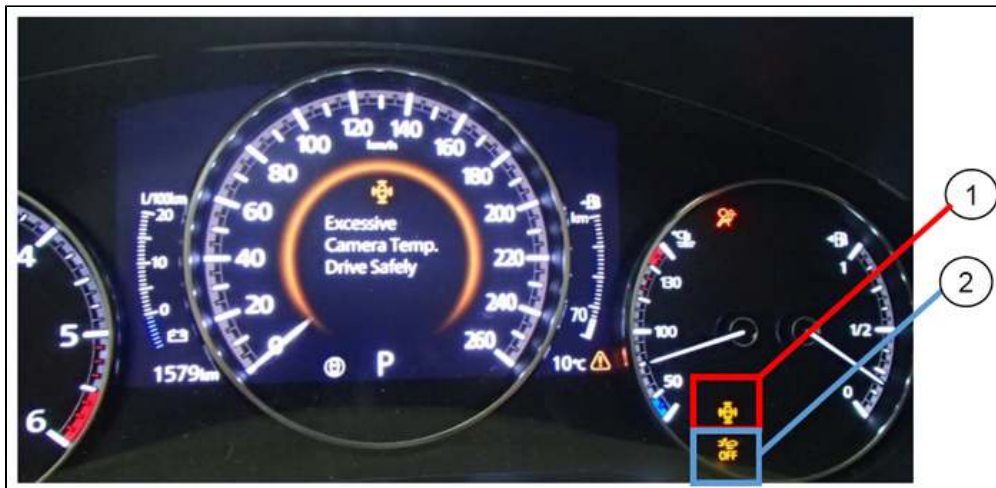
- i-ACTIVSENSE warning light ON (1)
- Smart Brake Support (SBS) indicator light ON (2)
- "Excessive Camera Temp. Drive Safely" or "Safety and Driver Support Systems Temporarily Disabled" warning messages
- DTC B14F9:00 stored in memory

DTC\_B14F9:00 is falsely stored instead of DTC B14F0:4B.

DTC\_B14F0:4B [VCM] (Forward sensing camera (FSC) internal temperature abnormality) - FSC detects temperature higher than operation range.

1. Verify customer concern.
2. Check for DTCs.

- **YES:** Go to MGSS DTC B14F0:4B [VEHICLE CONTROL MODULE]
- **NO:** This service information does not apply. Go to MGSS for normal diagnosis.

3. Contact Hotline for latest repair information.
4. Verify repair.
