| <b>HYUNDAI</b><br><b>Technical Service Bulletin</b> | <b>GROUP</b><br><b>AUTOMATIC TRANSMISSION</b> | <b>NUMBER</b><br><b>21-AT-007H</b> |
| <b>SUBJECT:</b><br>AUTOMATIC TRANSAXLE (8-SPEED FWD)<br>POSITION SWITCH DTC P070500, P070512, P070514,<br>P07051C, P070600, P070661 & P070696 DIAGNOSIS | | |

***This TSB supersedes TSB 20-AT-006H to add information and additional models.***

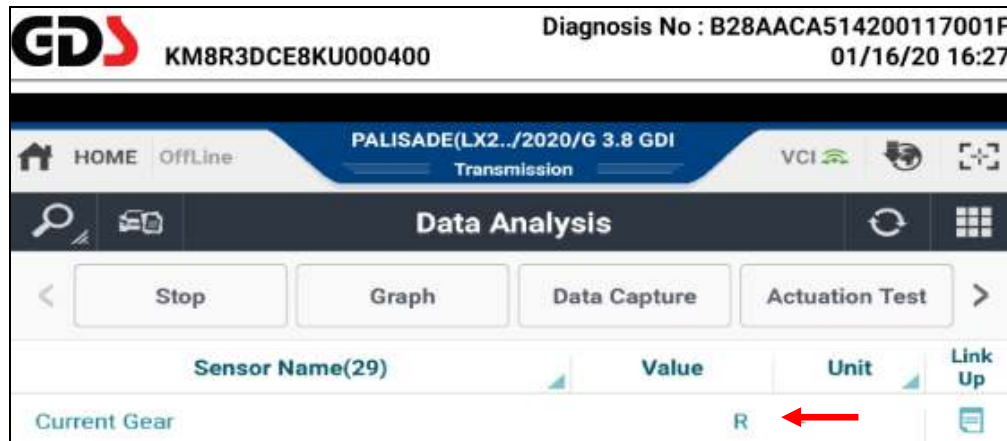
3. Select **Data Analysis**, **A/T** menu and **Current Gear**. Depress the brake pedal and move the shift lever through all gears (P, R, N and D) and monitor the **Current Gear**. Confirm the indicator on the cluster shows all gears. Turn the ignition **OFF**.

4. If the GDS shows:
  - The correct **Current Gear**, the wiring currently has no open/short circuits. Go to Step 6.
  - Does not show the correct **Current Gear**, go to Step 5.
5. Visually check the wiring harness between the ECU and position sensor (inhibit switch) for a damaged wire or open circuit/short circuit to ground. Check for a damaged pin or pin not fully inserted into the connector.
  - If damage is found, repair or replace the control wiring and drive the vehicle to confirm the repair.
  - If no damage or open/short circuit is found, go to Step 6.

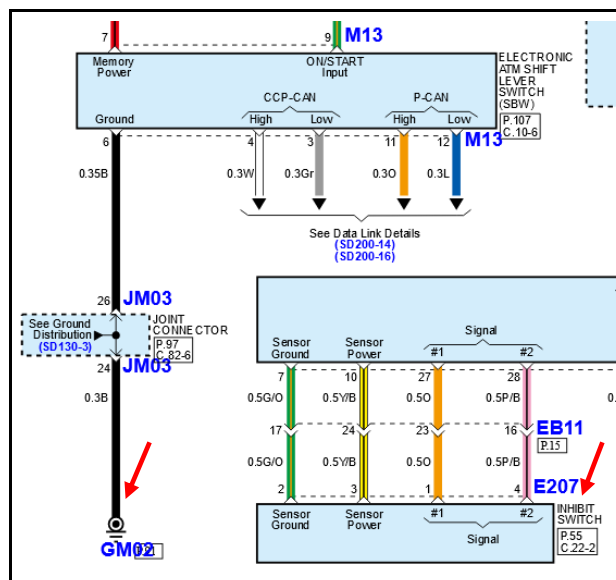
6. Check the grounds for the electronic shift lever. (Refer to ETM, SD450-1). Turn the ignition and headlights on. Use a DVOM to check the voltage drop between the wiring terminal and ground.

**Specification: Less than 0.2 V.**

- If more than 0.2V, clean the terminal and bolt threads and tighten the bolt.
- If less than 0.2V, go to Step 7.

**Torque: 7~9 lb-ft, 1.0~1.2kgf.m, 10~12 N.m**

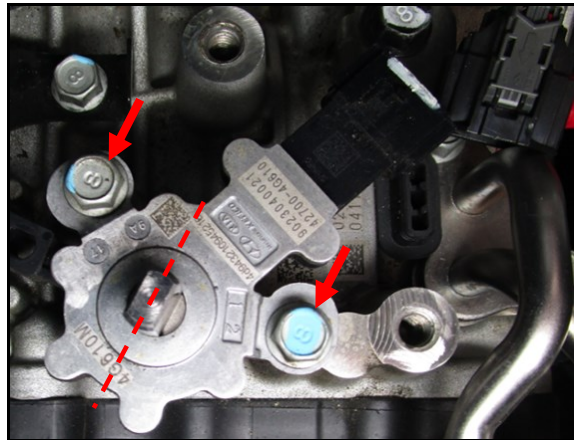
**NOTE:** The manual valve is shown in the Park position.

11. Remove 2 mounting bolts and remove the position sensor.

Install a new position sensor.

Install 2 bolts and loosely tighten the bolts.

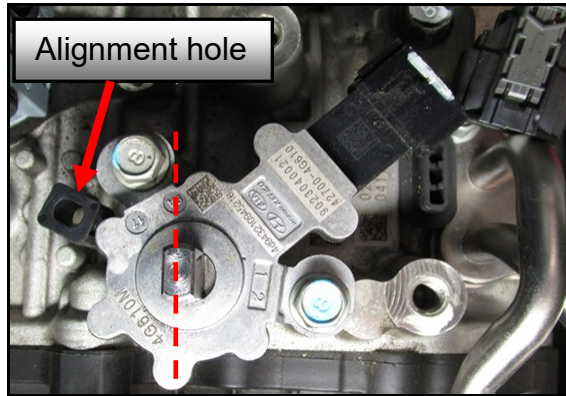
**NOTE:** The manual valve will be aligned 90° to the radiator.

12. Turn the manual valve 2 detents in the counter-clockwise direction to place the manual valve in the Neutral position.
