## Technical product information

| <b>Topic</b> | Warning light illuminated within the DIP - DTC C103711 - Evident within Address 74 |
| <b>Brand</b> | Bentley |
| <b>Transaction No.</b> | 2064338/1 |

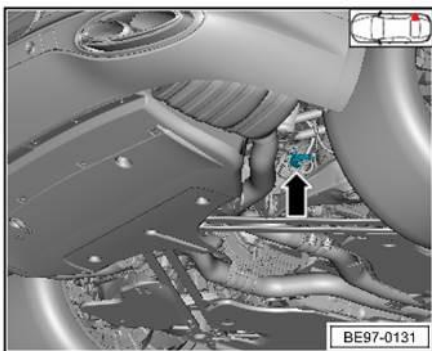
- Rear Right Height sensor (G77) connection – Visual and pull check
- Referring to Figure 1 - Perform a wiring integrity check between sensor (G77) and J775

3) If no fault is found during the wiring checks - Replace the level sensor (G77) - Rep.Gr 43

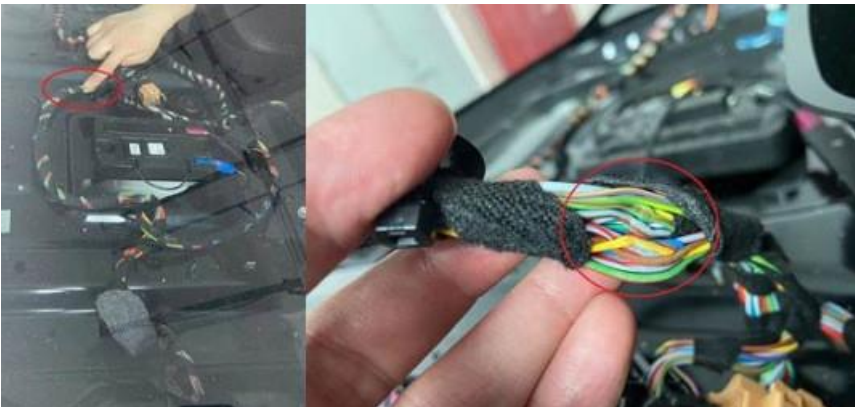
- Figure 2 shows examples of damaged wiring under parcel shelf

2) In the event that wiring is found to be damaged, the wiring should be repaired as per the applicable Rep.Gr
