# Technical Service Bulletin

## 43 Warning message in the cluster "Air suspension fault", DTC C11AFF0 is stored in the suspension module

43 21 55 2063660/2 September 7, 2021. Supersedes Technical Service Bulletin Group 43 number 21-49 dated June 14, 2021 for reasons listed below.

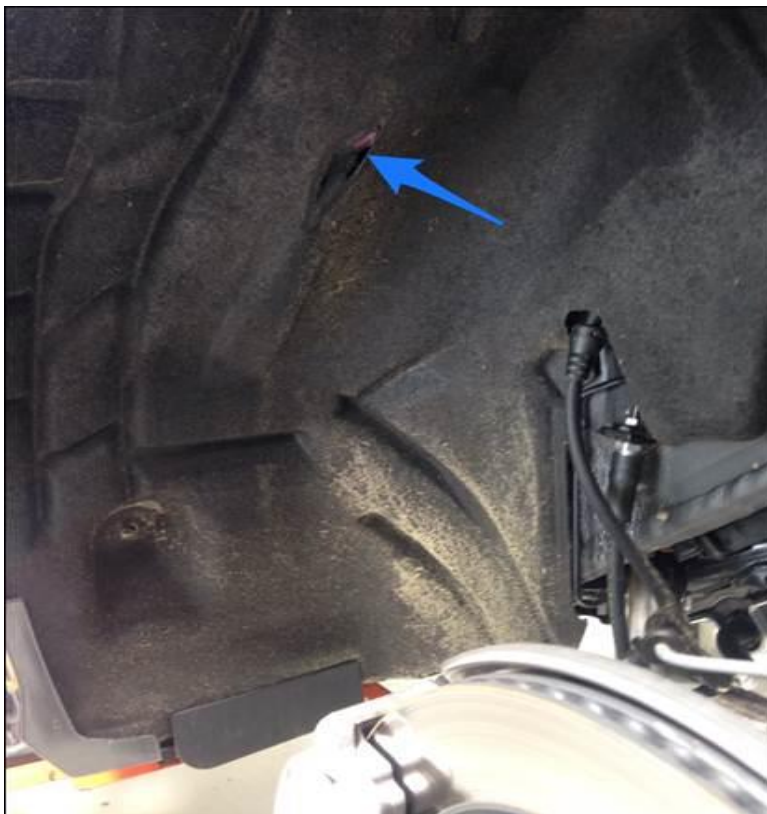
Incorrect air hose length around rear left wheel housing.

1. Check whether there are irregularities in the marked area of the rear left wheel housing liner (Figure 1).

**Figure 1.** Area of possible irregularities.

2. If there are irregularities in the marked area, follow steps 1 to 6 to correct the issue.
3. If there are **NO** irregularities in the marked area, perform diagnosis with GFF and tool VAS 751 001 to locate possible leaks/issues.

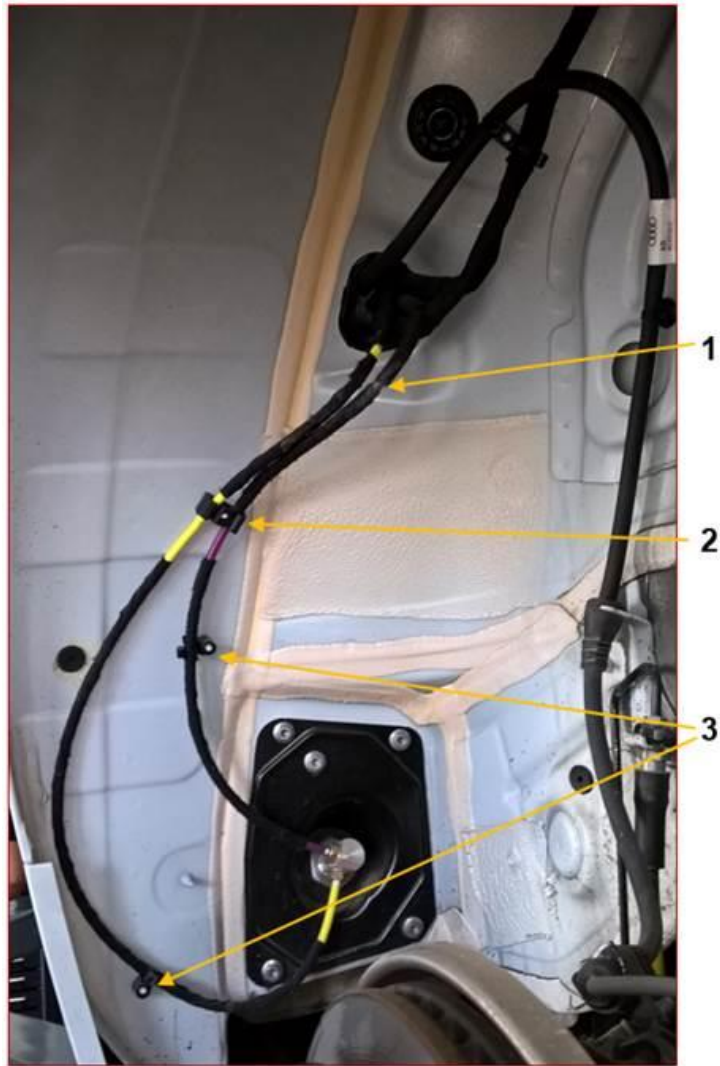
1. Check purple and yellow air hoses for damage (proceed with the repair, use only the repair kit set as described in ETKA) (Figure 2).

**Figure 2.** Area to be reworked.

2. Unclip both air hoses (Figure 2).
3. Loosen both cable ties (Figure 2).
4. Pull both air hoses down toward the accumulator and clip them in. Secure the hoses with a cable tie above the clip (the distance between the vehicle body and air hoses should be less than 35 mm) (Figure 3).

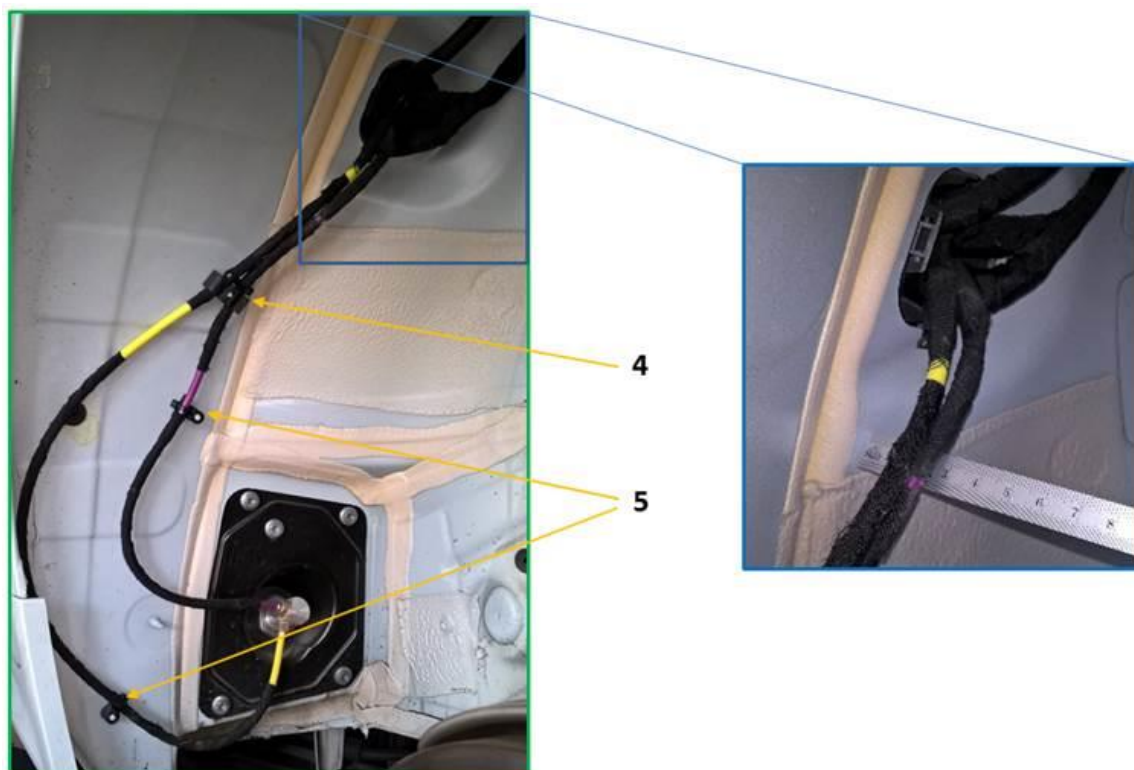
**Figure 3.** Close-up area: location where the distance between the vehicle body and air hoses should be less than 35 mm.

5. Secure the air hoses again at the intended locations with cable ties.
6. Replace the damaged wheel housing liner according to ETKA.
