# Technical Service Bulletin

## 91 SOS warning displayed in instrument cluster, DTC B191604 is stored in the gateway control module

91 21 32 2051664/4 September 16, 2021. Supersedes Technical Service Bulletin Group 91 number 20-58 dated December 18, 2020 for reasons listed below.

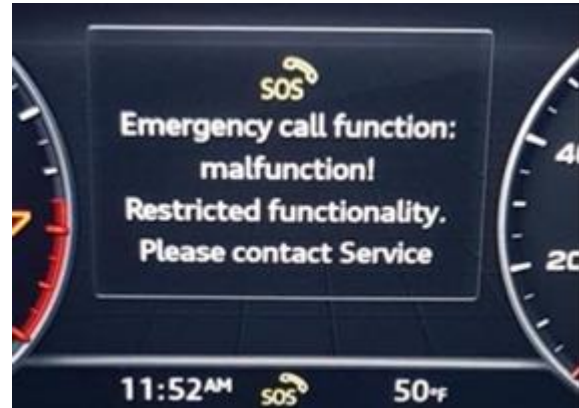
- The warning message “Emergency call function: malfunction! Restricted functionality. Please contact Service” appears in the instrument cluster (Figure 1).

**Figure 1.** The warning message is shown in the instrument cluster.

1. Perform a manual discharge of the connected gateway's backup battery by removing constant power (KL30) and accessory power (KL15), while KL15 is switched on.

If the fault does not clear and is marked as active/static, then replace the connected gateway's backup battery. Consult the Elsa Repair Manual for instructions on replacing the connected gateway's backup battery. Consult the parts catalog for the correct part number of the connected gateway's backup battery.

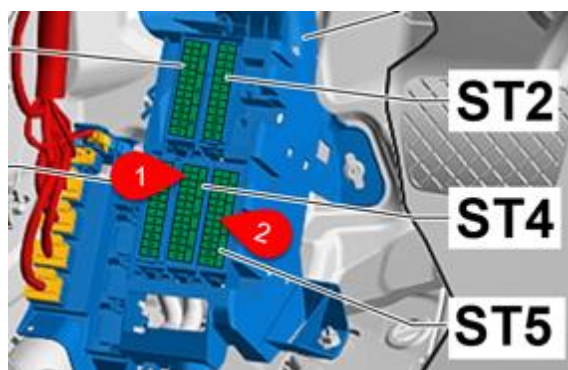
**Figure 2.** Q7 Driver's Side Footwell Fuse Box. 1: KL15 Fuse. 2: KL30 Fuse.

4. Ensure that accessory power (KL15) is ON.
5. Remove the two fuses identified in Step 3.
6. Wait 30 seconds with both fuses removed.
7. Reinstall the two fuses.
