## Technical product information

| <b>Topic</b> | Buzzing/vibration from the left and/or right headlamp and/or DTC's C119C01-C119D01 stored - Matrix beam headlamp only |
| <b>Transaction No.</b> | 2059246/3 |

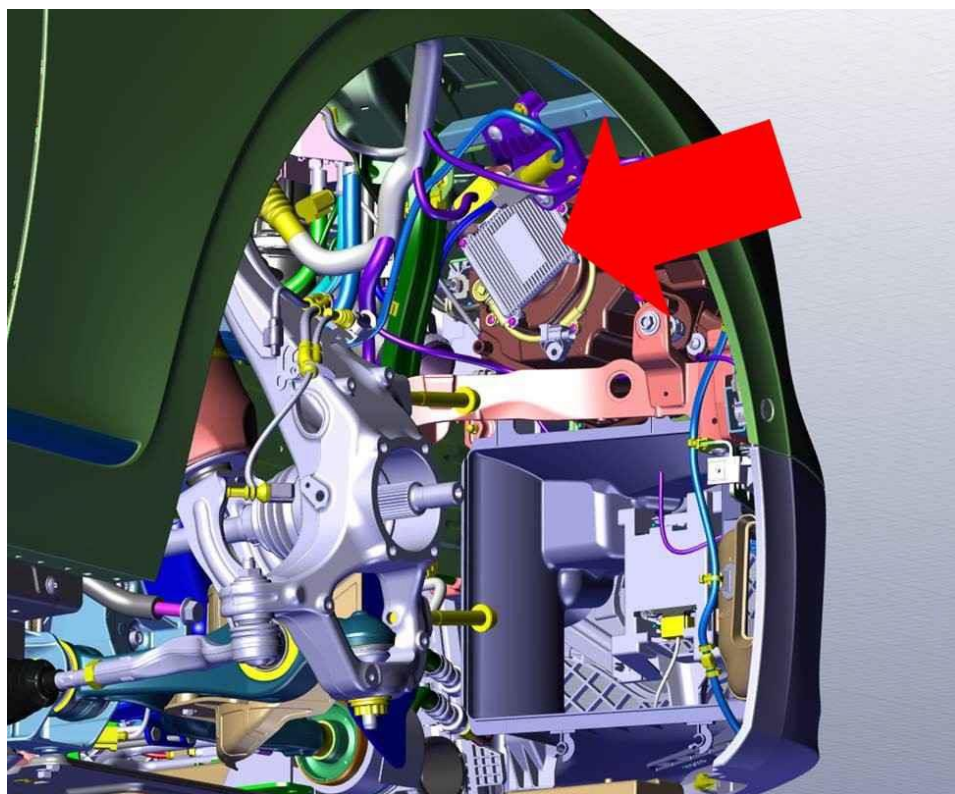
Wiring harness routed incorrectly within the headlamp module at the rear of the headlamp, the noise and DTC's are evident due to the harness contacting the headlamp cooling fan

- Remove the applicable front wheel arch liner - Rep.Gr 66
- Locate the module at the rear of the applicable headlamp as Figure 1
