# Technical Service Bulletin

## 01 Car jerks/bucks or hesitates while driving DTCs P023600 and/or P010600 are stored in the ECM

01 21 13 2062323/2 October 20, 2021. Supersedes Technical Service Bulletin Group 01 number 21-98 dated February 18, 2021 for reasons listed below.

| Model(s) | Year | VIN Range | Vehicle-Specific Equipment |
|---|---|---|---|
| A6 | 2018 - 2022 | All | 2.0TFSI |

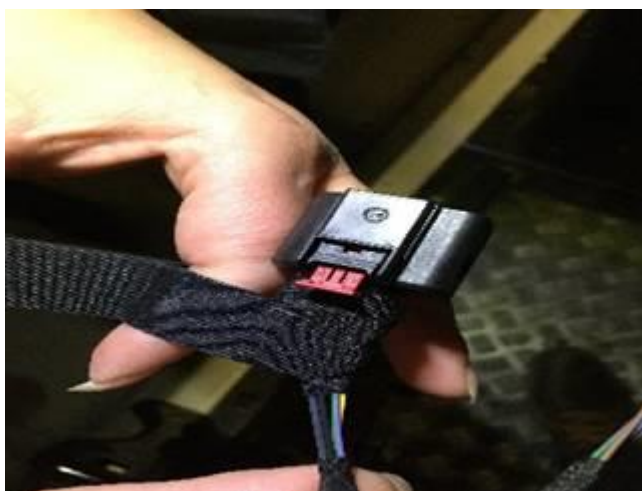
**Figure 4.** Wrapping the connector base part 2.

4. The tape must extend far enough to cover the connector base (Figure 4).

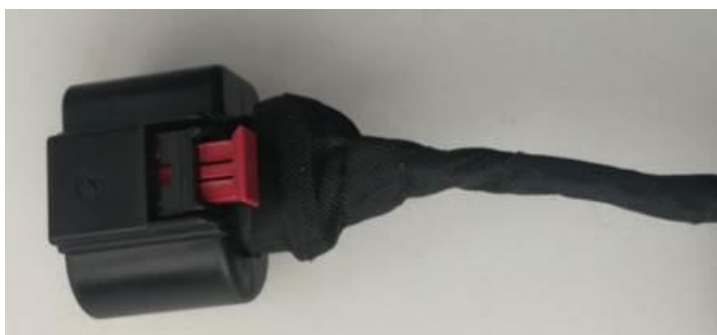
**Figure 5.** Completed harness wrapping.

5. Continue to wrap the exposed wires down the harness and slightly overlap the existing harness tape (Figure 5).
