# Technical Service Bulletin

## 91 SOS Warning displayed in instrument cluster, DTC B18BE13 or B18BD13 stored in the telematics control module

91 21 52 2054038/3 November 17, 2021. Supersedes Technical Service Bulletin Group 91 number 19-82 dated August 26, 2019 for reasons listed below.

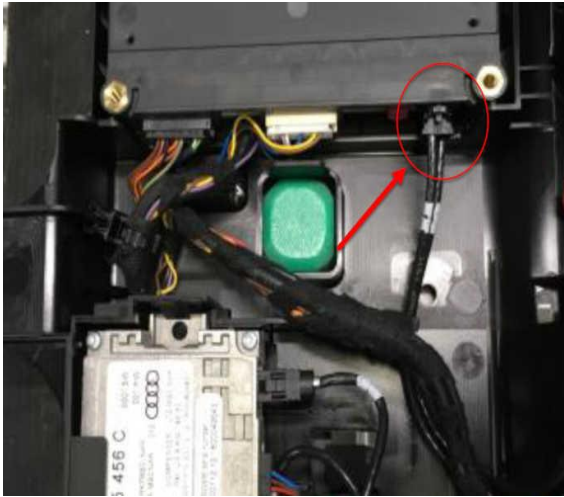
If the ConBox is not properly seated in its mount before the 4 pole antenna connector is connected, it can lead to the pins in the connector being widened, losing contact between the antenna and the ConBox.

**Figure 1.** Telematics Control Module (J949) Connector.

1. Remove the original 4 pole connector including its pins and remove a section of the vehicle's coaxial wiring for the applicable antenna circuit.

Measure the length of coaxial wiring to be removed based on the adapter antenna cable you are using. This will ensure that the removed section is the same length as the adapter antenna cable (000 098 714).

2. Replace the original 4 pole connector and cable with the new connector harness and pins.
3. Before plugging the new 4 pole connector in, make sure that the telematics control module, J949 (address word 0075) is mounted properly in its bracket.

Do not tilt the control module while plugging in the 4 pole connector. Tilting the control module while plugging the connector might damage the new pins.
