# Technical Service Bulletin

**94 Rear turn signal warning is displayed, DTCs B16D4F4, B16D5F4, B16D6F4, or B16D7F4 are stored in the comfort module**

94 21 49 2062241/2 November 19, 2021. Supersedes Technical Service Bulletin Group 94 number 21-35 dated February 23, 2021 for reasons listed below.

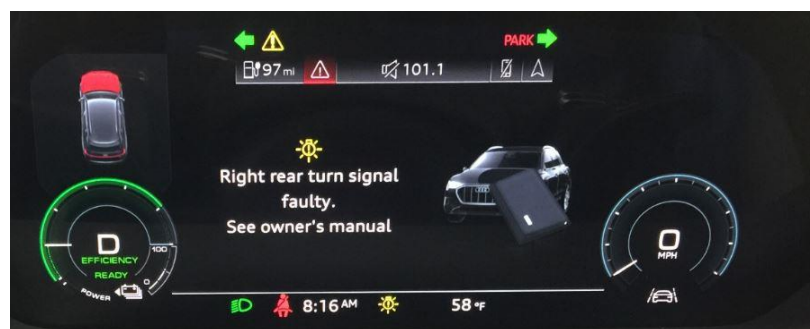
There is a timing issue in the tail lamp software.

1. When actuating the turn signal, a warning is displayed for the rear turn signal that was actuated (Figure 1).

**Figure 1.** Warning displayed for the right rear turn signal.

2. If the described condition is present, please proceed to update the software in the tail lamps.

3. Follow all instructions in TSB 2011732: *00 Software Version Management (SVM), operating instructions*.
4. Update the tail lamp software using the SVM action code as listed in the table below, if necessary:
