## STAR ONLINE PUBLICATION

**Case Number:** S2108000278

**Symptom/Vehicle Issue:** Pinched Front Passenger Door Harness Causes Stop/Start To Become Inoperative, Bus Not Go To Sleep And Door Panel Lights To Remain On. DTC's B2860-15 And P00FD

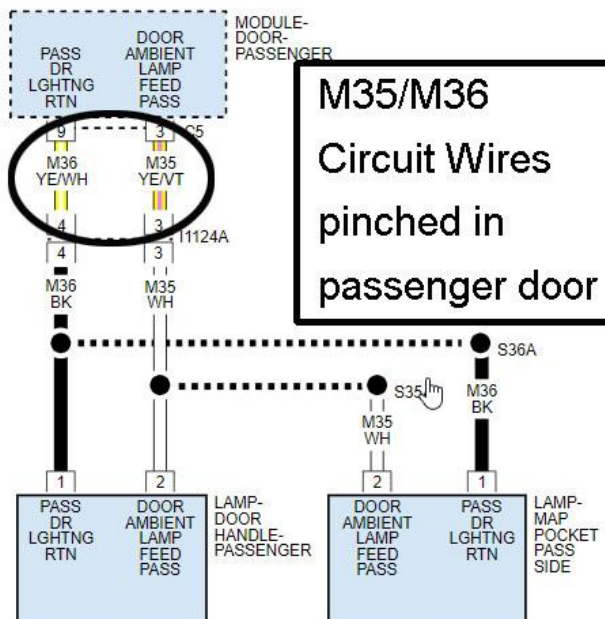
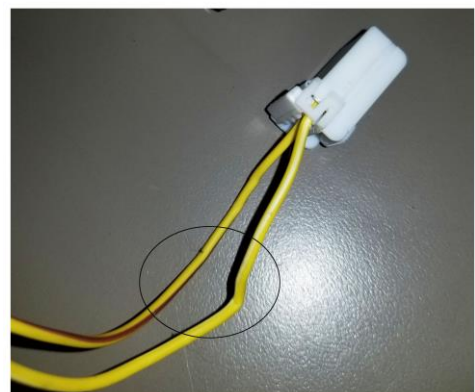
**Diagnosis:** Inspect for M35 circuit (YE/VT) Passenger Door Ambient Lamp Feed and M36 circuit (YE/WH) Passenger Door Lighting Return circuits for pinching or damage. These circuits have been found to be pinched in Passenger front Door Panel (Circuits part of Passenger Door 2 harness) and causing a Short to Battery.

M35/M36 Wires were Pinched in the Passenger Side Door

**Repair:** If this condition is found, repair/replace wiring for the passenger front door harness as required. Route the harness in such a way that it can no longer be pinched by the door panel upon installation.

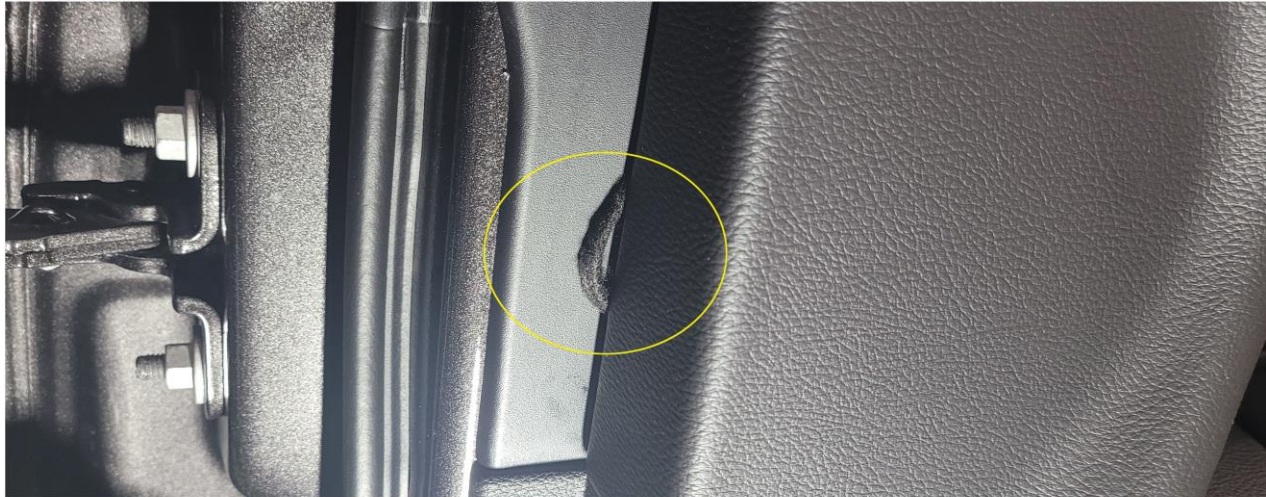
### Passenger Door Harness Pinched in Door Panel
