**FORD:**

2015 Transit

**TSB 15-0160 (Continued)**

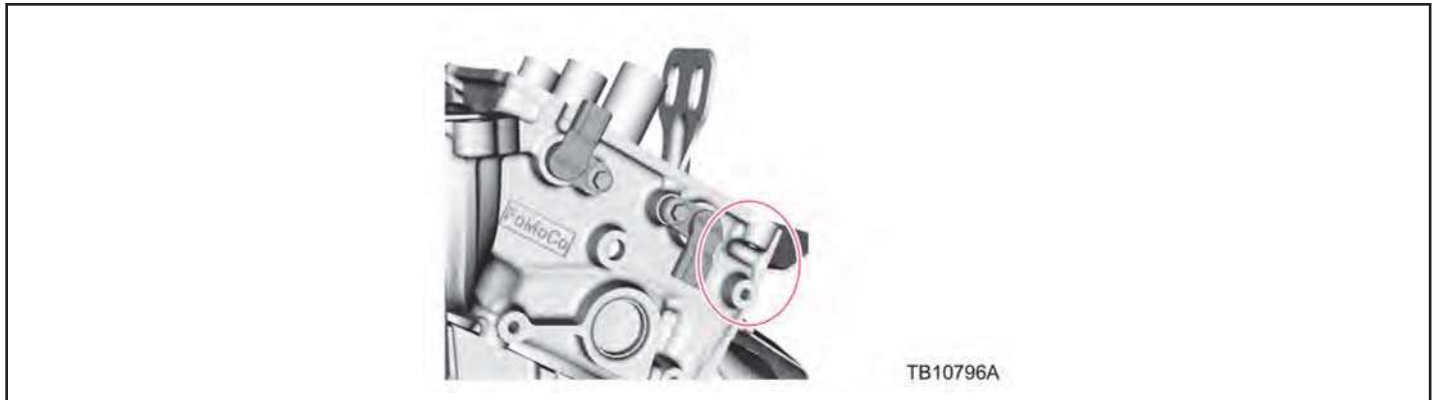
Figure 1 - Article 15-0160

14. Position the detached section of the harness on top of the engine to allow harness inspection and repair.
15. Inspect the harness takeout for HO2S11 electrical connector C1571 for chafing or wire worn through that may have been caused by contact on the back of the cylinder head. (Figure 1)

16. Repair any wire chafing found using the solder splicing method. Refer to Wiring Diagram Cell 5-1.
  - a. Use a commercially available sheathing ripper, such as Rotunda Technician Tool Program (RTTP) JSP95978-04 or equivalent, to carefully strip the wire harness tape from the section of wire harness.
  - b. Insert the ball end of the sheathing ripper into the wire harness. Use caution not to damage the wires or wire insulation when stripping the wire harness.
17. Use Coroplast™ tape or equivalent and wrap the affected area of the takeout to H02S11.
18. Properly route the harness and make sure the HO2S11 wire harness takeout is positioned correctly to prevent future chafing. (Figure 2)
