# Service Bulletin

Bulletin No.: 21-NA-255

Subject: Engine Mis fire, Malfunction Indicator Lamp (MIL) Illuminated - DTC P0300 Set

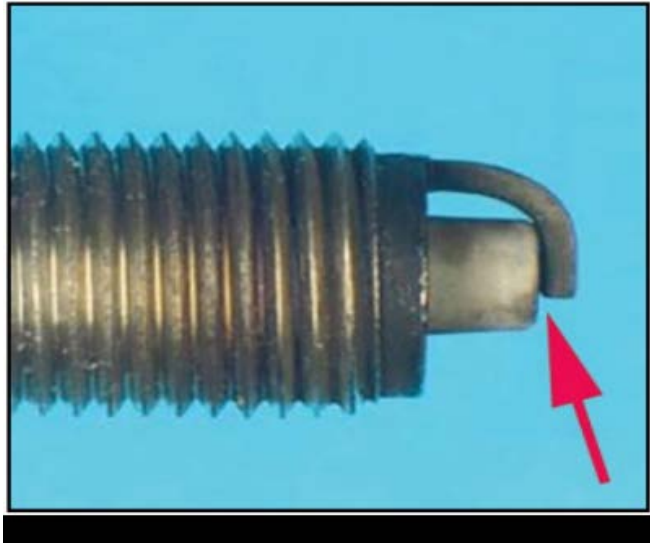
| Condition | Some customers may comment on one or more of the following conditions:<br>" MIL illuminated<br>" Engine misfire<br>Technicians may find DTC P0300 set in the Engine Control Module (ECM). |
| Cause | <p>5920461</p> <p>This condition may be caused by a broken spark plug insulator.</p> |

| Correction | <p>If you encounter a vehicle with an engine mis fire or engine misfire related DTC, perform the following:</p> <p>⇒ Remove the spark plugs from the engine and inspect for a broken center insulator by inverting the spark plug. Once the spark plug has been inverted, you may find the insulator will slide down the center electrode.</p> |

Refer to Gas Engine Ignition Spark Plug Inspection and Gas Engine Ignition Spark Plug Replacement in SI.
