## SERVICE BULLETIN

AT21-012

### DTC P0805 FOR CLUTCH POSITION SENSOR A STORED IN TCM

**APPLIED VEHICLES:** 2022 Pathfinder (R53)

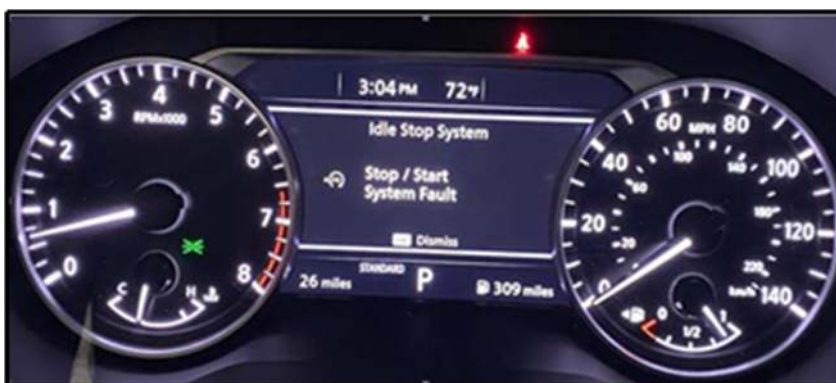
Figure 1

- The MIL was ON.
- The Idle Stop System Fault message (Figure 1) was displayed.
- They experienced a drivability concern.

1. Confirm the current TCM part number.
2. Reprogram the TCM, if applicable.
