## TECHNICAL SERVICE BULLETIN

### 3.5L PowerBoost - Reduced Engine Power, Illuminated MIL With DTCs P0299, P0301, P0302 And/Or P0303 - Built On Or Before 30-Sep-2021

**22-2017**

27 January  
2022

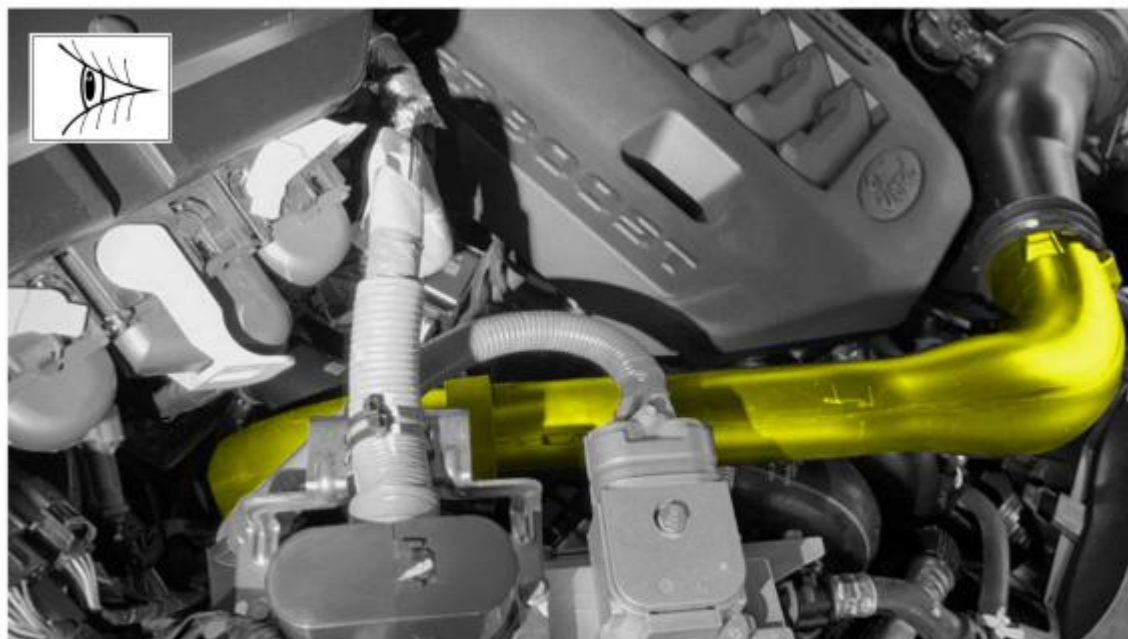
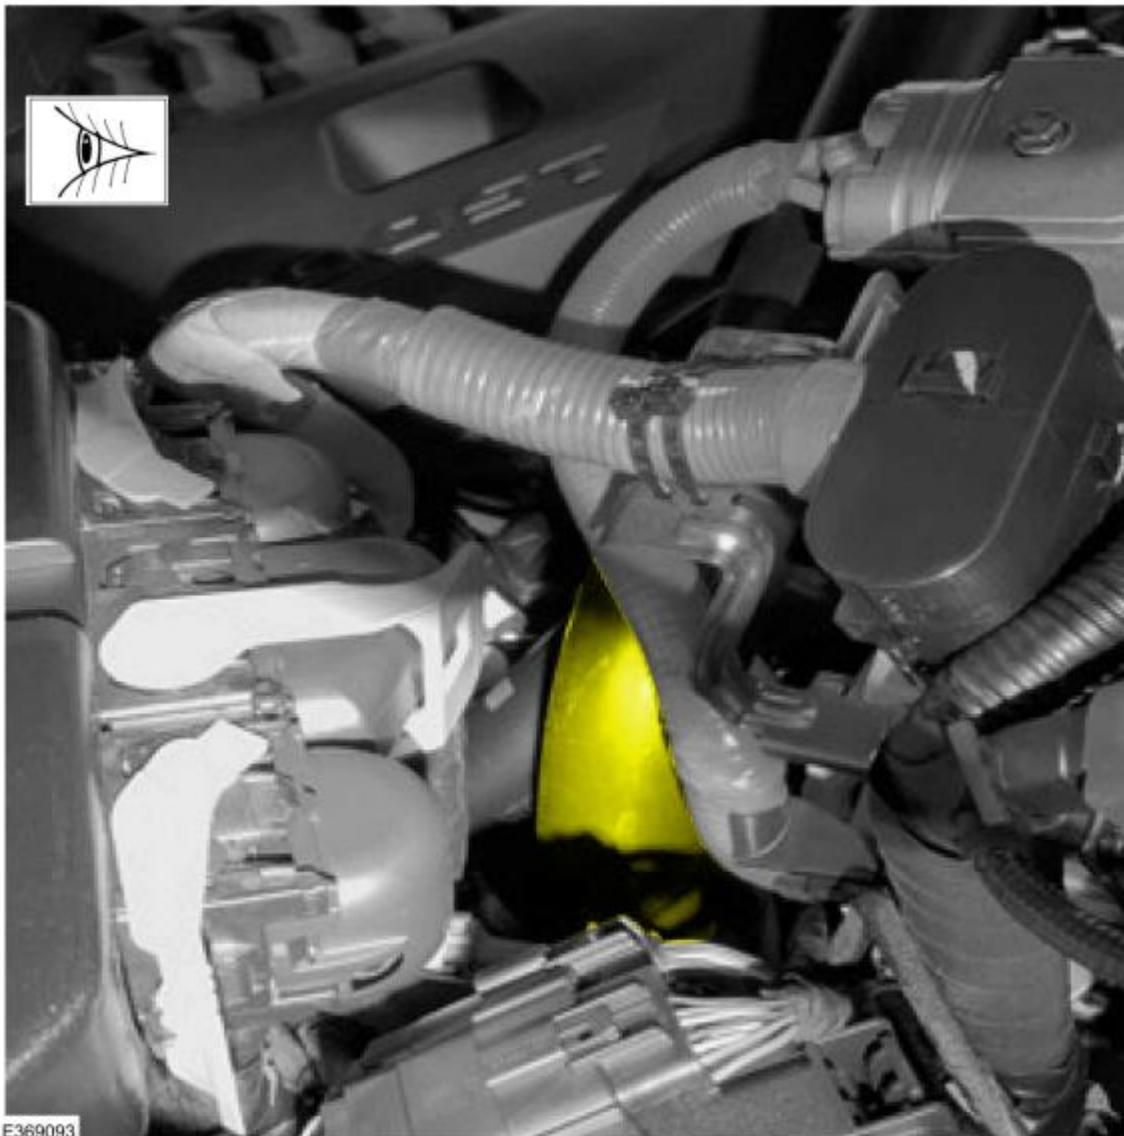
1. Inspect the right air cleaner outlet pipe (Figures 1-2) for a seam line in the section where the duct begins to route downwards towards the turbocharger (Figure 3). Does the right air cleaner outlet pipe exhibit a seam line?

- (1). Yes - remove the right air cleaner outlet pipe. Refer to Workshop Manual (WSM), Section 303-12D > Intake Air Distribution and Filtering > Removal and Installation. Proceed to Step 2.
  - (2). No - this article does not apply. Refer to WSM, Section 303-04I.
2. Inspect the right turbocharger for damage and/or oil leaking from the compressor wheel. Refer to the WSM, Section 303-04I > pinpoint test Step C6. Does the turbocharger exhibit damage in the turbine shaft or in the
