GLOBAL SAFETY FIELD INVESTIGATIONS  
DCS5456  
URGENT - DISTRIBUTE IMMEDIATELY

Subject: A202304840-01 - Service Update  
Camshaft Actuator Oil Control Valve Center Bolt Binding  
Revised service procedure, parts information, warranty information,  
and added floor plan.

Models: 2020 – 2021 Buick Encore GX  
2021 Chevrolet Trailblazer  
Equipped with 1.3L Turbo Engine(RPO L3T)

### A202304840 Camshaft Actuator Oil Control Valve Center Bolt Binding

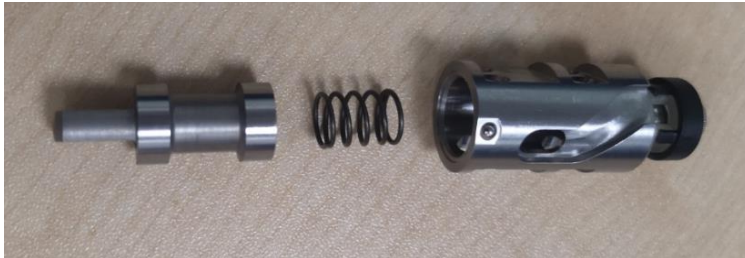
5627953

7. The removed bolt sleeve kit should look as shown – a plastic over molded sleeve.
