# SERVICE CAMPAIGN BULLETIN

EC21-016

NTB22-006

## VOLUNTARY EMISSION SERVICE CAMPAIGN 2013-2016 SENTRA; ECM REPROGRAM AND OXYGEN SENSOR VOLTAGE INSPECTION

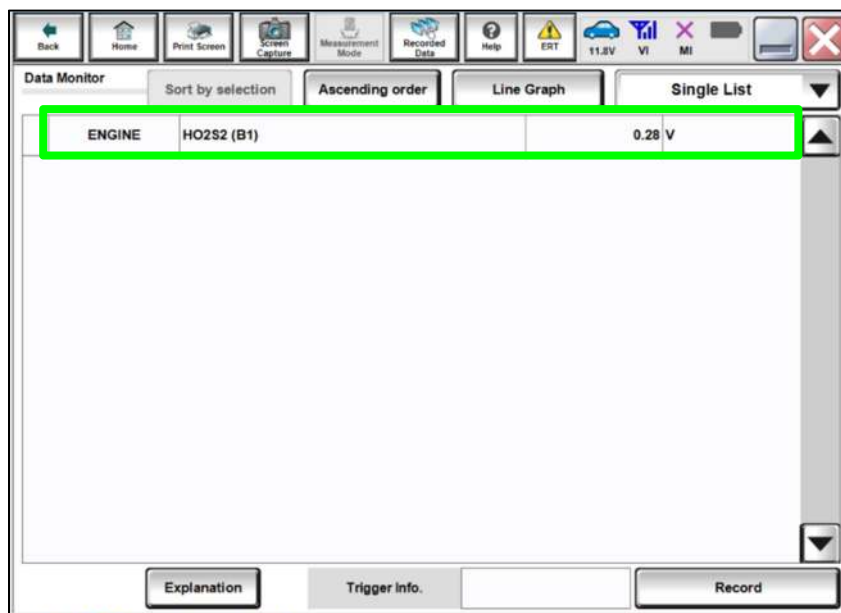
Figure 6

9. Check the Rear O2 Sensor (**HO2S2 (B1)**) voltage in the data monitor screen (Figure 6).
- If the **HO2S2 (B1)** voltage is 0.13 V or above, no further action is needed. The inspection result is **OK** and the **SERVICE PROCEDURE** is complete, skip to **CLAIMS INFORMATION** on the last page.

- If the **HO2S2 (B1)** voltage is less than 0.13 V, the rear O2 sensor has a short to ground condition and the inspection result is **NG**.
    - a. Print the data monitor screen and attach it to the repair order.

- b. Diagnose and repair the Rear O2 Sensor short to ground condition by following the diagnosis steps outlined in the ESM for DTC P0137 (HO2S2).
      - Refer to the ESM: **ENGINE > ENGINE CONTROL SYSTEM > MRA8DE > DTC/CIRCUIT DIAGNOSIS > P0137 HO2S2 > Diagnosis Procedure**

- NOTE:** Follow the diagnosis and repair procedure even if DTC P0137 is not present.
- c. Proceed to step 10 to perform the drive pattern to set the System Readiness Test (SRT) status.
