# Technical Service Bulletin

## 93: DTC(s) P0A4000, P0A2E00 or P0A2B00 stored in the Electric Drive Control Module

93 22 69 2066596/1 March 25, 2022.

| Model(s) | Year | VIN Range | Vehicle-Specific Equipment |
|---|---|---|---|
| A7 e quattro | 2021 – 2022 | All | Not Applicable |

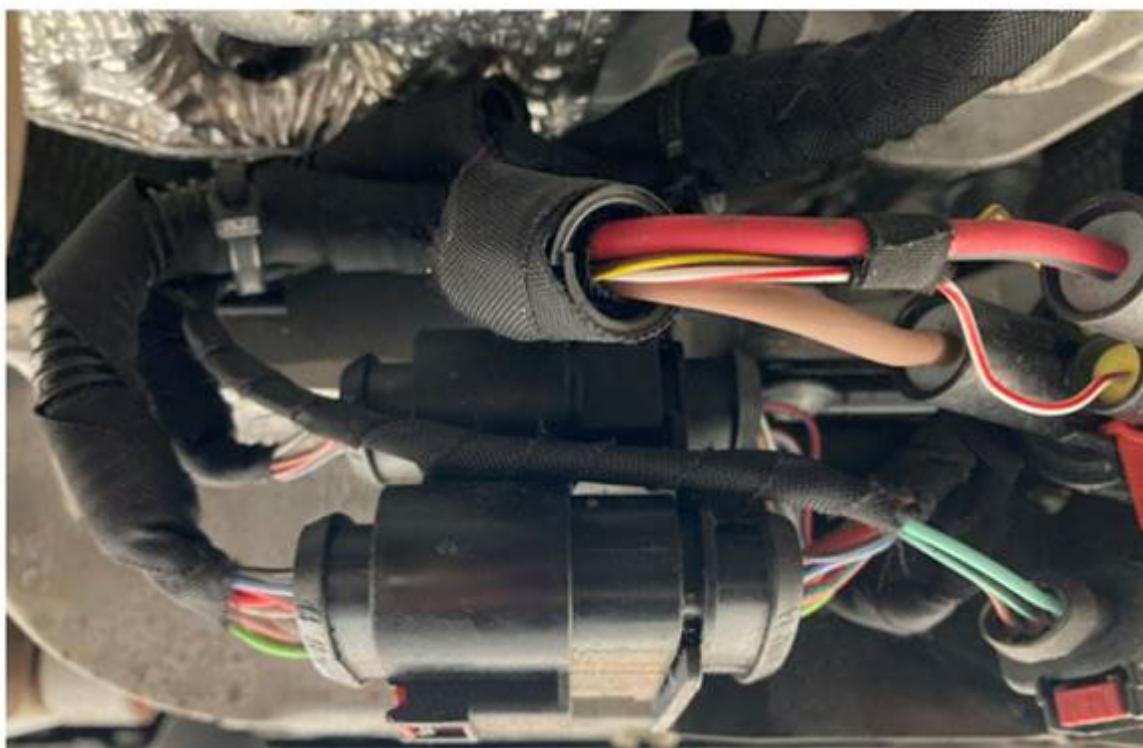
Contact abrasion in connector T6bm / T6bmX.

**Figure 1.** Connectors in the wrong position.

1. Check on the transmission bracket whether connector T6bm is installed at the top or the bottom of the bracket. The six-pin connector must be installed in the bottom position and the fourteen-pin connector T14k must be installed at the top.
2. If the connectors are in the wrong position (Figure 1), install them in the correct position (Figure 2).

3. To fix the complaint, unplug the six-pin connector and check the pins. If you do not identify any irregularities on the pins, plug the connector back in. Then erase all DTC memory entries and perform an extensive road test. If the complaint does not reoccur, the vehicle can be returned to the customer and the repair is done. Unplugging the connector and plugging it back in again renews the contact between the pins. This improves the contact resistance and should resolve the complaint. However, if the complaint reoccurs during the road test proceed to step 4.
4. If the complaint reoccurs or this TSB has been performed in the past, replace all the pins in the six-pin connectors T6bm / T6bmx with gold-plated pins from VAS 1978B wiring repair kit. Delete all DTC and confirm the repair with a test drive.
