## Technical product information

| <b>Topic</b> | Warning light illuminated within the DIP - DTC C103711 - Evident within Address 74 |
| <b>Brand</b> | Bentley |
| <b>Transaction No.</b> | 2064338/2 |

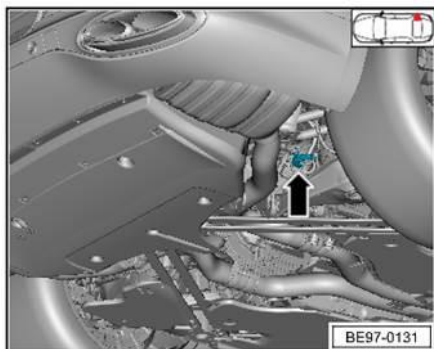
- Rear Right Height sensor (G77) connection – Visual and pull check
- Referring to Figure 1 - Perform a wiring integrity check between sensor (G77) and J775

3) If no fault is found during the wiring checks - Replace the level sensor (G77) - Rep.Gr 43

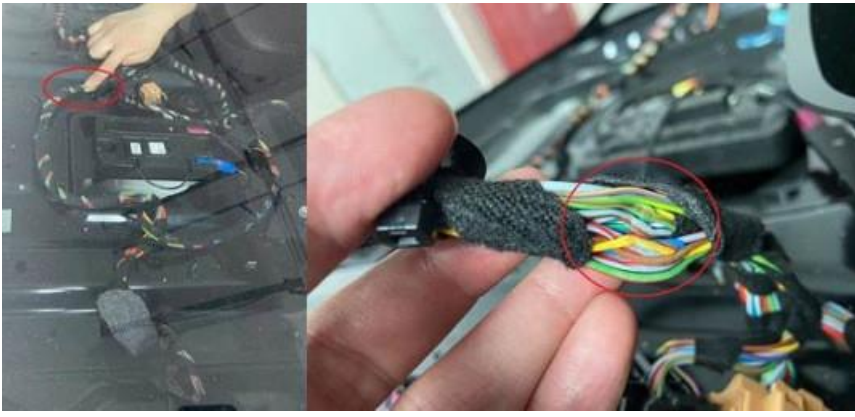
- Broken wires
- Kinked wiring
- Loose Rear Right Height sensor G77 connection
- Defective Rear Right Height sensor G77

- Figure 2 shows examples of damaged wiring under parcel shelf

2) In the event that wiring is found to be damaged, the wiring should be repaired as per the applicable Rep.Gr
