## Technical product information

| <b>Topic</b> | Warnings within the DIP for the rear steering system - DTC P060700 evident within diagnostic address 00CB |
| <b>Brand</b> | Bentley |
| <b>Transaction No.</b> | 2066511/1 |

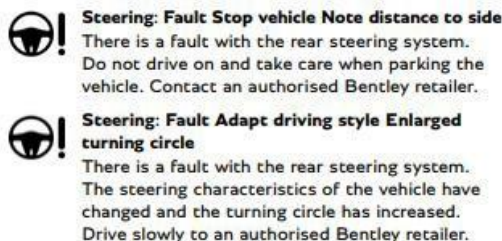
Figure 1

- Warnings within the DIP for the rear steering system (Figure 1)

- DTC P060700 evident within diagnostic address 00CB - Rear Axle Steering control module

1) Inspect the rear wheel steering control unit/J1019 (rear steering rack) for signs of the following:

2) Referring to the applicable wiring diagram, conduct an electrical integrity check for the rear wheel steering control unit/J1019 (rear steering rack)

- Refer to the applicable wiring diagram - Check earth point 710 for Cleanliness, security and integrity
- If no faults were identified after conducting the wiring integrity checks - Refer to Rep.Gr 48 - Replace the rear wheel steering control unit/J1019 (rear steering rack)
