## Technical Service Bulletin

**22-01-030H**

**ELANTRA (AD/ADa)**

**TCU UPDATE AND IVT REPLACEMENT  
(SERVICE CAMPAIGN 963)**

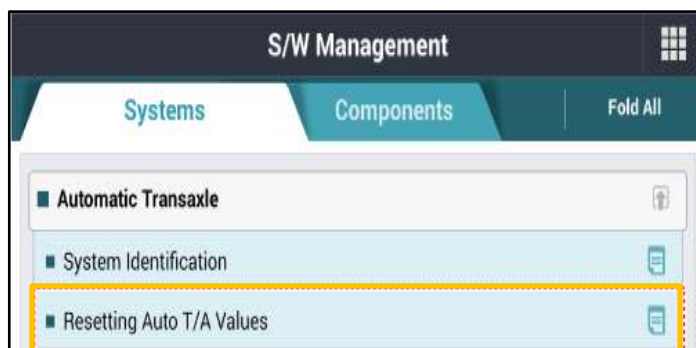
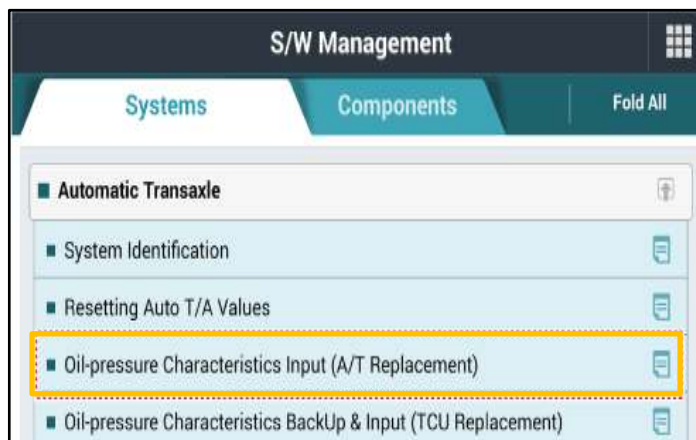
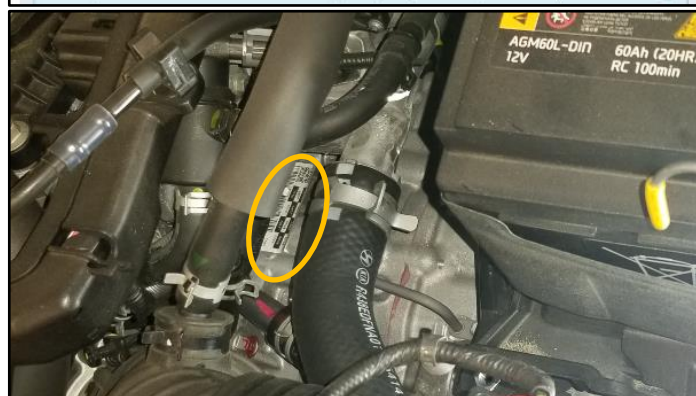
IVT oil pressure characteristics label is located on the IVT bell housing.

1. Perform IVT Resetting Auto T/A Values and Oil-pressure Characteristics Input procedures using the GDS-M.

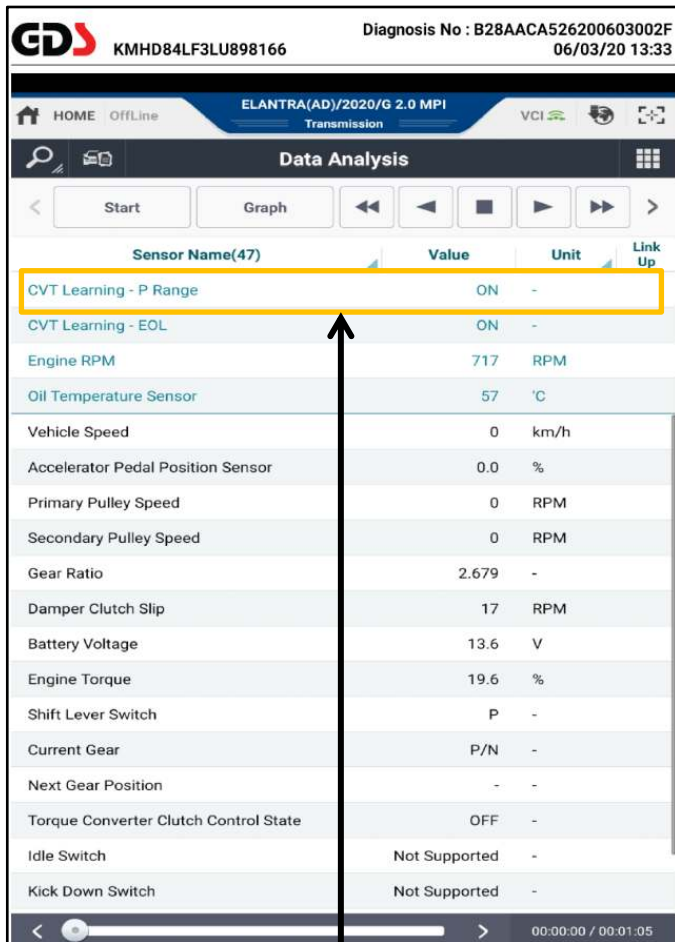
Use the GDS-M to verify the IVT P-Range learning is complete, and check TCU for DTC P1603 (EOL P-Range Pressure Learning Failed).

Learning completion can be confirmed by using GDS-M to verify the IVT ("CVT") P-Range learning value is "ON". ("OFF" learning has not been completed)

(1) If IVT- P Range learning is not complete, and P1603 is present, replace the IVT (Refer to **Section D.**)

(2) If IVT-P Range is not complete, and P1603 is not present, the learning condition has not been met. Re-perform **Section C** - IVT, TCU Learning.
