# Service Bulletin

Bulletin No.: 22-NA-079

**Subject:** Poor Engine Performance in Extremely Cold Weather Conditions for LSY Engines, Charge Air Cooler Icing, Malfunction Indicator Lamp (MIL) Illuminated with P0299

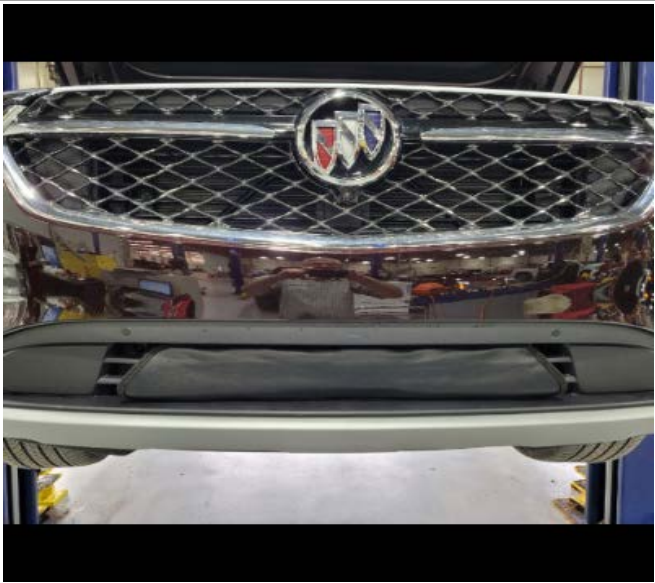
6029252

| Cause | This condition may be caused by ice accumulation in the charge air cooler (CAC), restricting air flow. |

| Correction | <br><br>A winter grille cover has been released to address this issue. |
