**BSM OFF INDICATOR ON WITH DTC U1A4B:97 OR U3000:97**

**Bulletin No:** 15-002/15

**Last Issued:** 12/10/2015

2016 MX-5 vehicles with VINs lower than JM1ND\*\*\*\*\*104338 (produced before August 20, 2015)

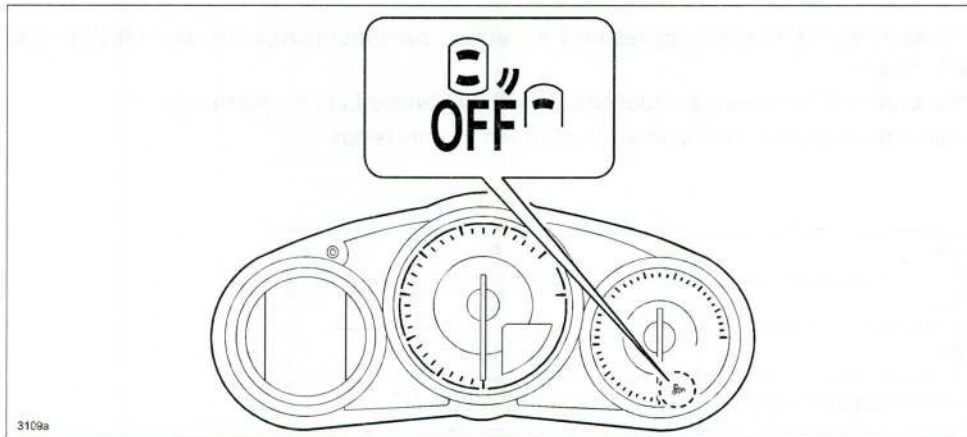
Some vehicles with Blind Spot Monitoring (BSM) may experience the following conditions (similar to when the BSM control modules detect dirt on the rear bumper surface):

- The BSM turns "OFF" and the BSM OFF indicator turns "ON" in the instrument cluster while driving
- The BSM will not turn on again during the drive cycle
- After cycling the ignition switch off and on again, the BSM operates normally
- DTC U1A4B:97 or U3000:97 is stored in memory
  - DTC U1A4B:97 - Radar sensor sensitivity temporarily decreases depending on various external and environmental factors (blind spot monitoring (BSM) control module (RH))
  - DTC U3000:97 - Radar sensor sensitivity temporarily decreases depending on various external and environmental factors (blind spot monitoring (BSM) control module (LH))

To correct this problem, the control logic of the BSM control modules has been changed.

1. Verify customer concern.
2. Replace both the BSM control modules with modified ones according to the instructions on MS3 online or the Workshop Manual (section 09-10 BLIND SPOT MONITORING (BSM) CONTROL MODULE REMOVAL/INSTALLATION).
