Preliminary Information

PIT5912B Lane Keep Assist Unavailable / Adaptive Cruise Control Inop / Service Driver Assist Systems / Amber Front Collision Icon On / Dead Battery / No Crank / Front View Camera DTC U3000 49

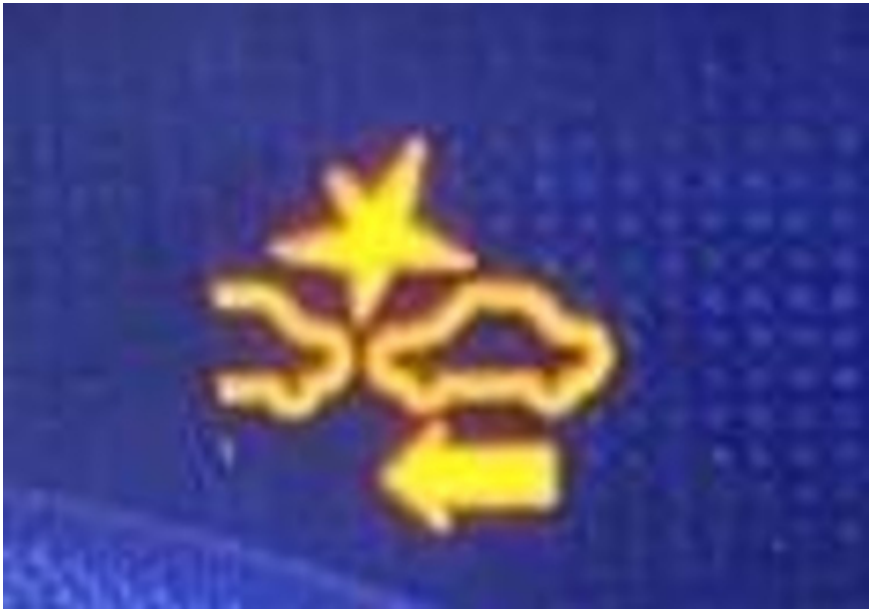
| Condition | <p>Some customers may comment on an amber Forward Collision icon displayed in the IPC, as shown below. Also, DTC U3000 sym49 may or may not be set current in the Front View Camera Module. In some cases, there could be a low or dead battery condition. Customers may also notice certain features related to the Front View Camera are unavailable, such as:</p> <ul style="list-style-type: none"><li>- Forward Collision Alert (RPO: UEU)</li><li>- Following Distance Indicator (RPO: UE4)</li><li>- Low Speed Collision Mitigation Braking (RPO: UHY)</li><li>- Pedestrian Collision Mitigation Braking (RPO: UKJ)</li><li>- Lane Keep Assist (RPO: UHX)</li><li>- Automatic High Beam Assist (RPO: TQ5)</li><li>- Adaptive Cruise Control (RPO: KSG)</li></ul> |
| Cause | The cause of this concern could be Onstar performing a task, which causes the B174W Front View Camera to set the DTC and disable during the next vehicle start up. |

**Note:** If the battery was low or dead, then charge and test the battery. The battery may require charging a second time before it will pass the test.

1. Turn the ignition off.
2. Remove the F11DR fuse for the B174W Front View Camera, located in the X51R Right Instrument Panel Fuse block.
3. Leave the fuse removed for 1 minute, then reinstall the fuse.
4. Clear any DTC's and check camera operation.
5.
  - If the camera operation has returned, then no further action is required.
  - If the camera operation has NOT returned, then perform a camera relearn using GDS2.
6.
  - If the camera operation has returned after the camera relearn, then no further action is required.
  - If the camera operation has NOT returned after the camera relearn then perform normal SI diagnostics and repair as necessary.
