**NUMBER:** 08-098-15

Hands Free Feature Inoperative

**\*\*2013 - 2016\*\*** (PF)

**\*\*Dodge\*\*** Dart

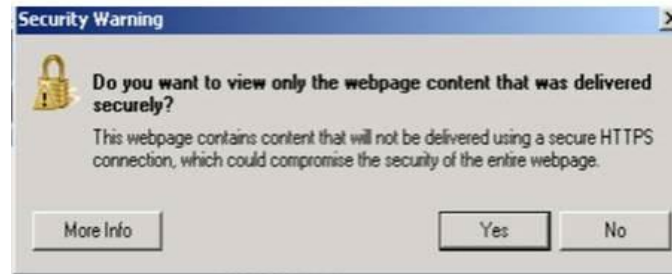
***Fig. 1 Pop-up Security Message***

16. If a security message appears "Do you want to view only the webpage content that was delivered securely?" See ([Fig. 1](#)). Press **No** to continue.
