**NUMBER:** 25-003-13

Malfunction Indicator Lamp Illumination Due To Oxygen Sensor

| 2011 | (DJ) | Ram Pick Up (2500) |
| 2011 | (D2) | Ram Pick Up (3500) |

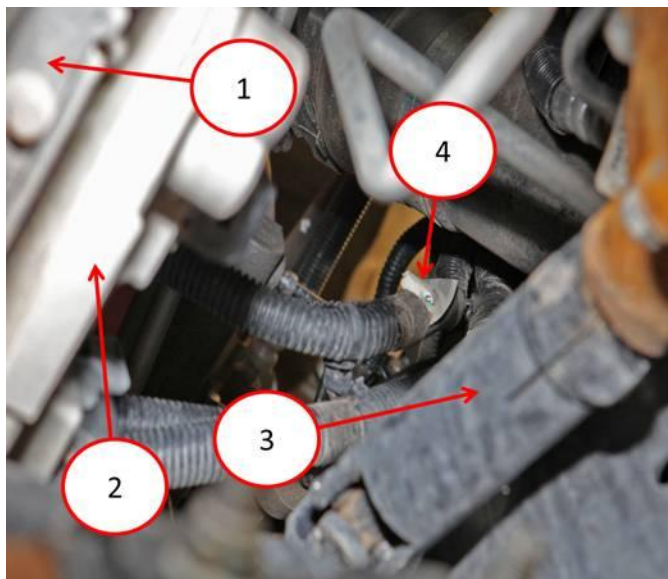
**Fig. 1 LOCATION OF TRANSMISSION HARNESS TAG, VIEWED FROM BELOW**

- 1 - Engine Oil Pan
  - 2 - PCM
  - 3 - Steering Shaft
  - 4 - Transmission Wiring Harness Tag Location
-

1. Determine if the Oxygen Sensor Module wiring harness terminals require replacement. Inspect the tag on the Transmission Wiring Harness for the part number suffix (the last two digits). This wiring harness tag is attached to the harness at a point usually most visible from under the hood. Initially, it is easiest to locate the tag from under the vehicle. Follow the harness from the PCM (front) connector up to the takeout that heads toward the driver's side of the vehicle. The tag is located on this takeout, near the frame rail, behind the left front wheel well splash shield. See (Fig. 1) and (Fig. 2) for tag location references.

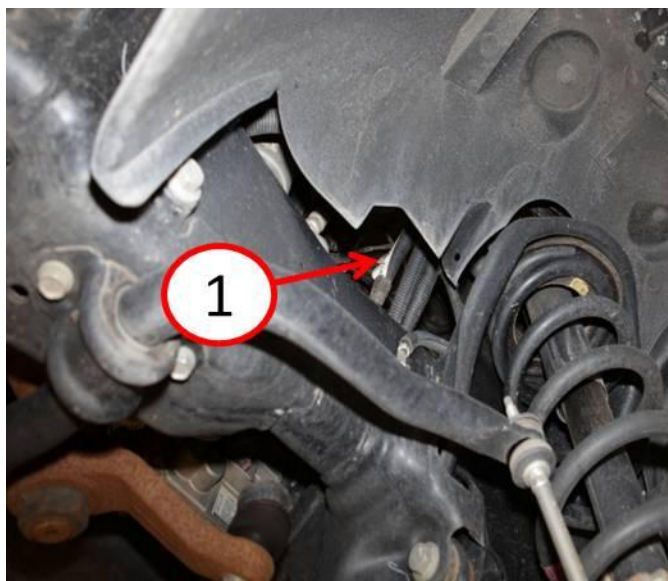
**Fig. 2 TRANSMISSION HARNESS TAG, VIEWED FROM LEFT WHEEL WELL**

1 - Transmission Tag as Visible Through Drivers Side Wheel Well

2. The harness part number is located on the left side of the tag between the two bar codes. Does the part number end with the suffix AC ?
  - a. Yes >>> If the suffix is AC, The Repair Procedure for Module Connector **IS** required. Perform the repair procedure below.
  - b. No >>> This bulletin does not apply. Ensure SB's 25-004-12 and 18-012-12 REV. A (or later bulletins) have been completed.

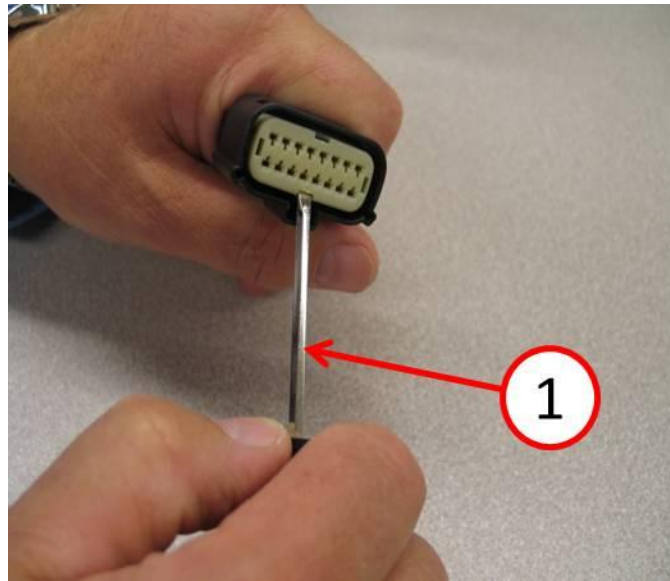
**Fig. 3 PRY OUT THE TPA 5MM**

1 - Small Blade (3mm Wide Max) Screwdriver

1. Open hood.
2. Disconnect and isolate both negative battery cables.
3. Raise and support vehicle on a suitable hoist.
4. Disconnect the **Oxygen Sensor Module Connector** and remove the protective tape and plastic shield on the connector.
5. Using a narrow blade, flat screwdriver (3 mm wide max), pry the white TPA (white cover seen when looking in connector). Notice the travel of white TPA is only 5 mm or until a "click" is heard. This is the release point of the TPA. The TPA is a device that locks the release finger so that when seated, terminal will not and cannot be disengaged, (Fig. 3) and (Fig. 4).

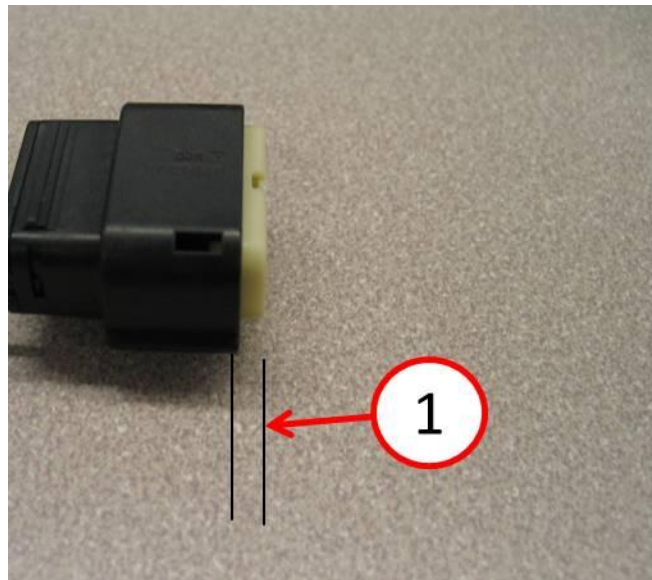
**Fig. 4 TPA EXTENDED 5MM**

1 - Extend TPA 5MM Only

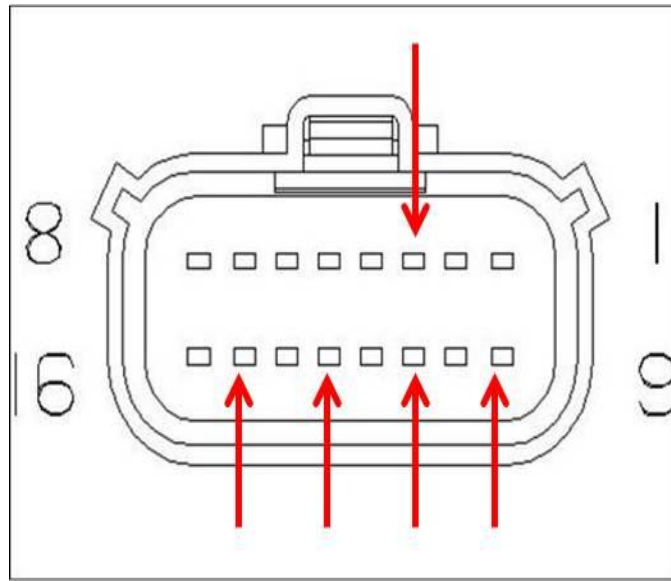
**Fig. 6 TERMINALS TO BE REPLACED**

This bulletin involves **inspecting for the part number of the transmission harness and based on the part number suffix, determining if the Oxygen Sensor Module Connector requires repair.** Some model year 2011 harness' were built with tin plated terminals in 5 of the connector cavities that should have been gold plated. Based on the transmission harness part number, the terminals will be replaced as required.

Replace Terminals Indicated By Red Arrows

8. Replace terminals #3, 9, 11, 13 & 15 (one at a time) as called out with RED ARROWS in (Fig. 6) with the gold terminal / pigtail included in Wire Repair Kit, p/n 68203454AA. The pigtail splice points should be staggered to eliminate bulk in the harness;

- a. Cut each wire, (one at a time) in a staggered manner.
  - b. Slide heat shrink tube on wire prior to splicing. Strip insulation on each wire and crimp together using band clamp **BEFORE SOLDERING** using Mopar splice band tool, p/n 05019912AA (or equivalent) then solder the crimped connection and heat shrink each wire individually.
