Preliminary Information

PIT5912C Lane Keep Assist Unavailable / Adaptive Cruise Control Inop / Service Driver Assist Systems / Amber Front Collision Icon On / Dead Battery / No Crank / Front View Camera DTC U3000 49

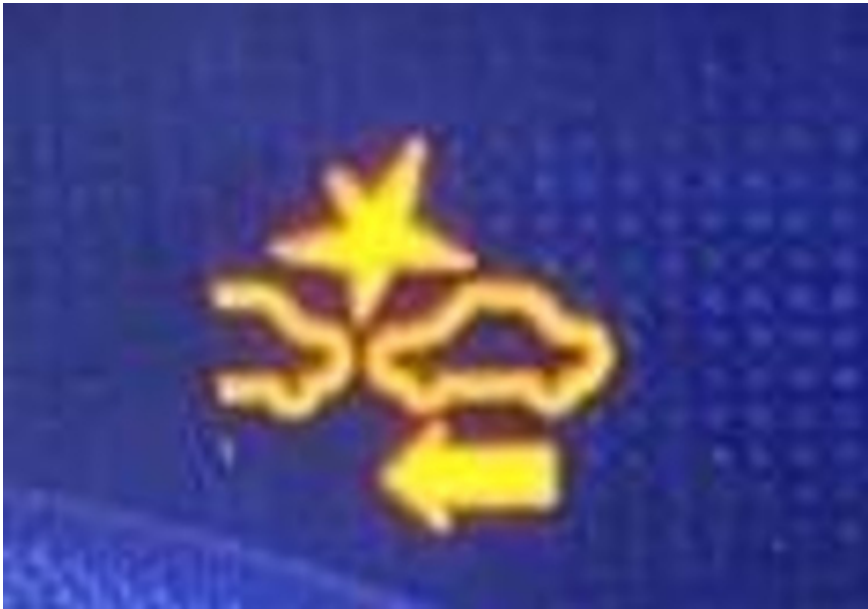
| Condition | <p>Some customers may comment on an amber Forward Collision icon displayed in the IPC, as shown below. Also, DTC U3000 sym49 may or may not be set current in the Front View Camera Module. In some cases, there could be a low or dead battery condition. Customers may also notice certain features related to the Front View Camera are unavailable, such as:</p> <ul style="list-style-type: none"><li>- Forward Collision Alert (RPO: UEU)</li><li>- Following Distance Indicator (RPO: UE4)</li><li>- Low Speed Collision Mitigation Braking (RPO: UHY)</li><li>- Pedestrian Collision Mitigation Braking (RPO: UKJ)</li><li>- Lane Keep Assist (RPO: UHX)</li><li>- Automatic High Beam Assist (RPO: TQ5)</li><li>- Adaptive Cruise Control (RPO: KSG)</li></ul> |
| Cause | The cause of this concern could be Onstar performing a task, which causes the B174W Front View Camera to set the DTC and disable during the next vehicle start up. |

1. Turn the ignition off.
2. Remove the F11DR fuse for the B174W Front View Camera, located in the X51R Right Instrument Panel Fuse block.
3. Leave the fuse removed for 1 minute, then reinstall the fuse.
4. Clear any DTC's and check camera operation.
5.
  - If the camera operation has returned, then no further action is required.
  - If the camera operation has NOT returned, then perform a camera relearn using GDS2.
6.
  - If the camera operation has returned after the camera relearn, then no further action is required.
  - If the camera operation has NOT returned after the camera relearn then perform normal SI diagnostics and repair as necessary.

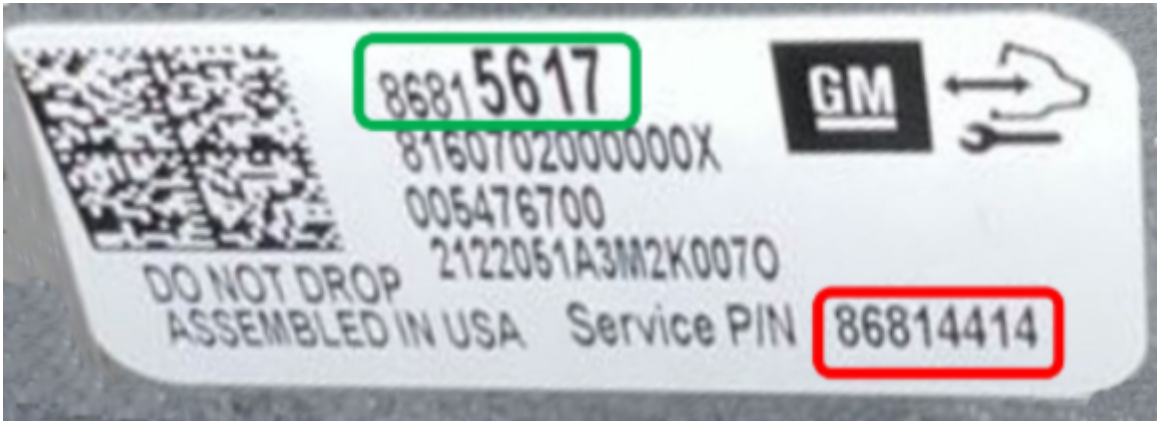
**Note:** If it is necessary to replace the Front View Camera, be sure to use the correct Part Number listed in the Electronics Parts Catalog. The Original Front View Camera may have "Service P/N 86814414" printed on the label (circled in red below) and that is the incorrect Part Number for this vehicle. Correct Part Number to use is in location circled in green below. If the part was ordered incorrectly it can be returned to the PDC using the correct MR return code.
