**NUMBER:** 18-068-16

MIL Illumination: DTCs P112C and/or P112D

This bulletin involves replacing the Post Catalyst Position O2 Sensor.

2015 - 2016 (KL) Jeep Cherokee

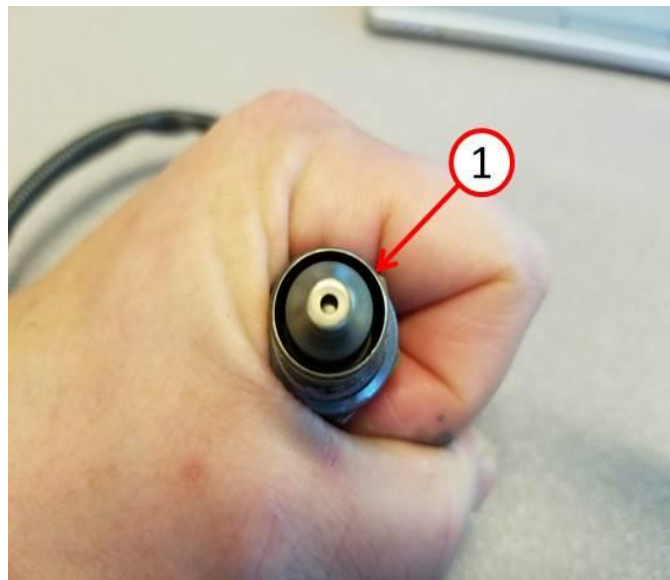
**Fig. 1 Old O2 Sensor**

3. Examine oxygen sensor and identify if it is the old design ([Fig. 1](#)) or if it is the new updated design([Fig. 2](#)).

1 - Old sensor (without holes)

4. Is the oxygen sensor that was removed the old design?
  - a. YES>>> Install the new updated design oxygen sensor.
  - b. NO>>> This Bulletin does not apply. Normal diagnosis should be performed.
5. Clear any DTCs that may have been set in any modules.
6. Lower the vehicle. Refer to the detailed service procedures available in DealerCONNECT> TechCONNECT under: Service Info> 04 - Vehicle Quick Reference> Hoisting> Standard Procedure.

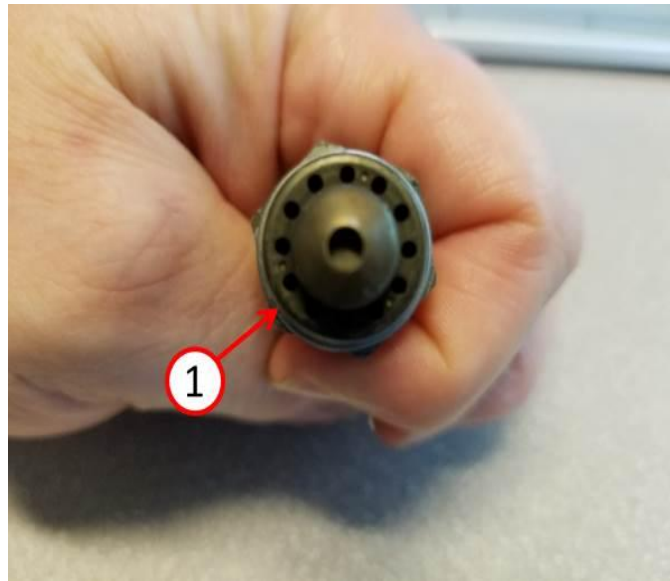
**Fig. 2 New O2 Sensor**

1 - New sensor (with holes)

**NOTE: The oxygen sensor should only be replaced with the updated design.**
