| GROUP | MODEL |
|---|---|
| ELE | 2017-2018MY<br>Sedona (YP) |
| 259 | August 2022 |

## TECHNICAL SERVICE BULLETIN

### SIDE AIRBAG (SAB) WARNING LIGHT ON WITH DTC(S) B1378/B1382

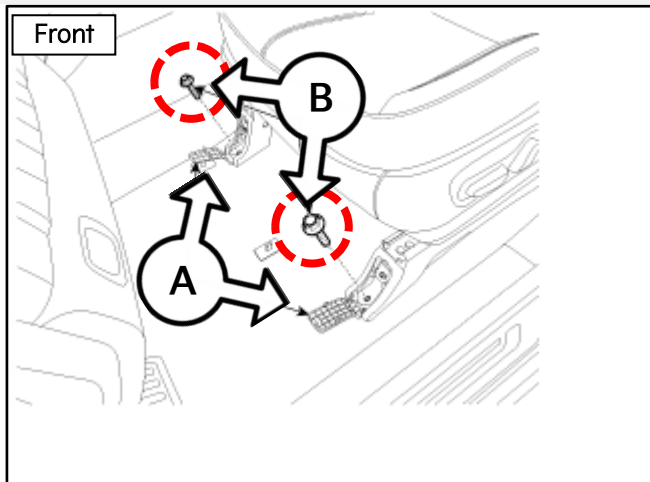
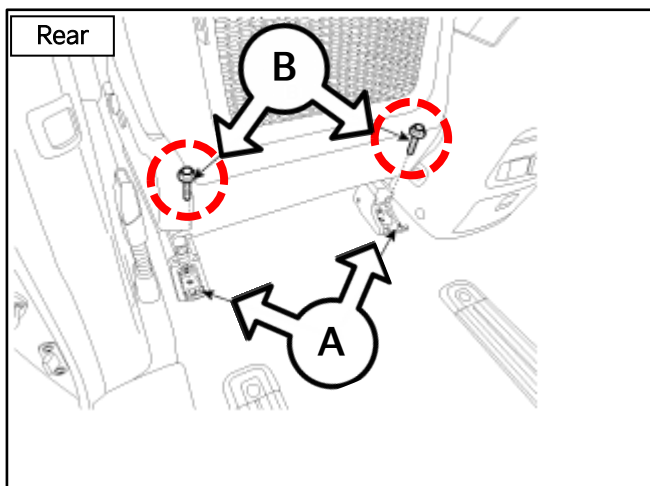
**Note:** Driver side (LH) front seat illustration shown for reference use only.

1. Open the seat mounting bolt caps (A) and loosen the four (4) seat retaining bolts (B) located on the front and rear of the affected front seat.

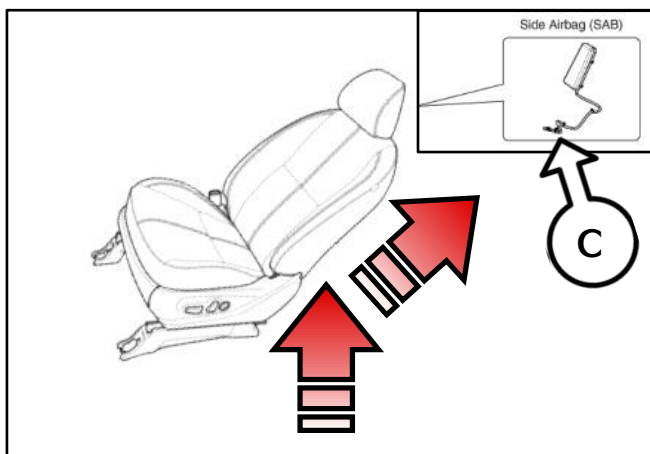
**Note:** Remove any foreign objects from under the seat as they may interfere with wiring and connectors (ex. bottles, personal objects, etc).

- 2a. Tilt the front of the seat backwards and locate the yellow airbag connector (C).
