**NUMBER:** 08-085-14 REV. A

**GROUP:** Electrical

Hands Free Feature Inoperative

2013 - 2014 (PF) Dart

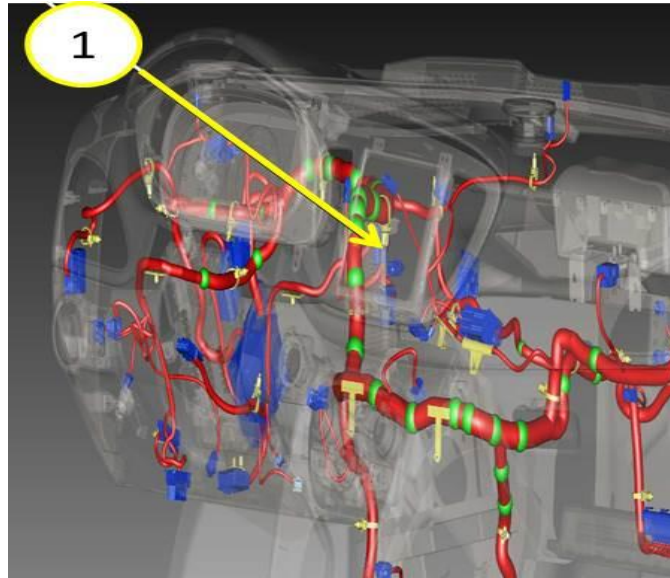
**Fig. 2 CTM Location Under The Dash**

1 - CTM location

19. **\*\*Gain access to the CTM, refer to TechConnect > Electrical/8E - Electronic Control Modules/MODULE, Convergence Telematics/Removal, CTM location see ([Fig. 2](#)).\*\***
