**Subject:**

INFOTAINMENT SPEAKER STATIC OR NO AUDIO SOUND AND  
DTC U2145:08/U0186:08 STORED

Service Alert No.: SA-058/22

2023 CX-50

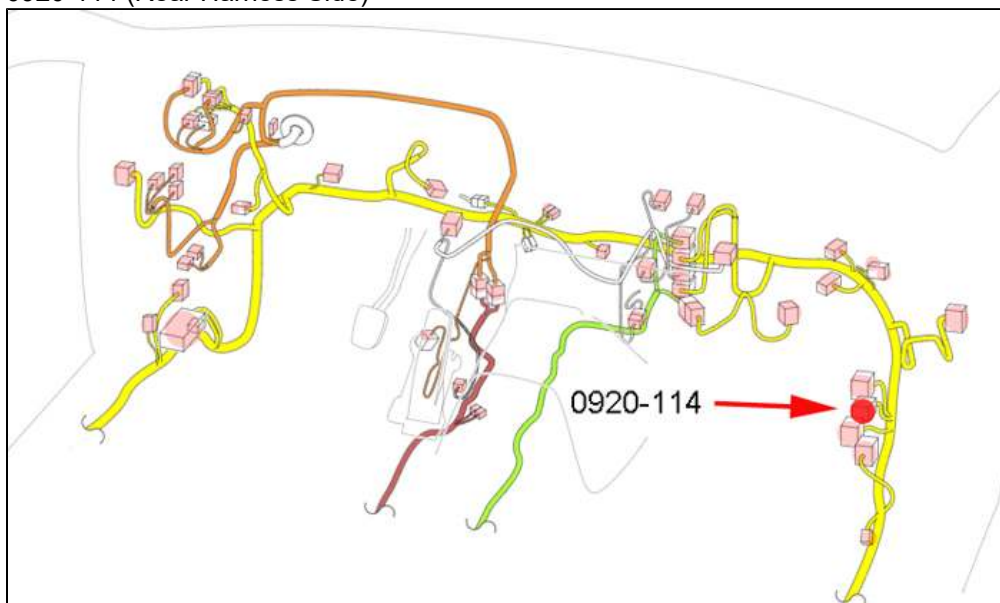
0920-114 (Rear Harness Side)

This may be caused by poor electrical connection at connector 0920-114 and/or 0920-115D (Rear Harness Side).

- **Yes** - Go to next step.
- **No** - Secure/lock the connector 0920-114 and/or 0920-115D properly.

- **Yes** - Repair/Replace Wiring Harness as needed.
- **No** - This service information does not apply. Go to normal DTC troubleshooting on MGSS.
  - DTC U2145:08 [CONNECTIVITY MASTER UNIT]
  - DTC U0186:08 [CONNECTIVITY MASTER UNIT (US)]

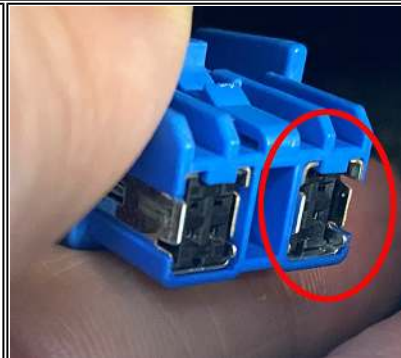
09020-115D connector pushed back
