## STAR ONLINE PUBLICATION

**Case Number:** S1918000008 Rev. C

**Release Date:** August 2021

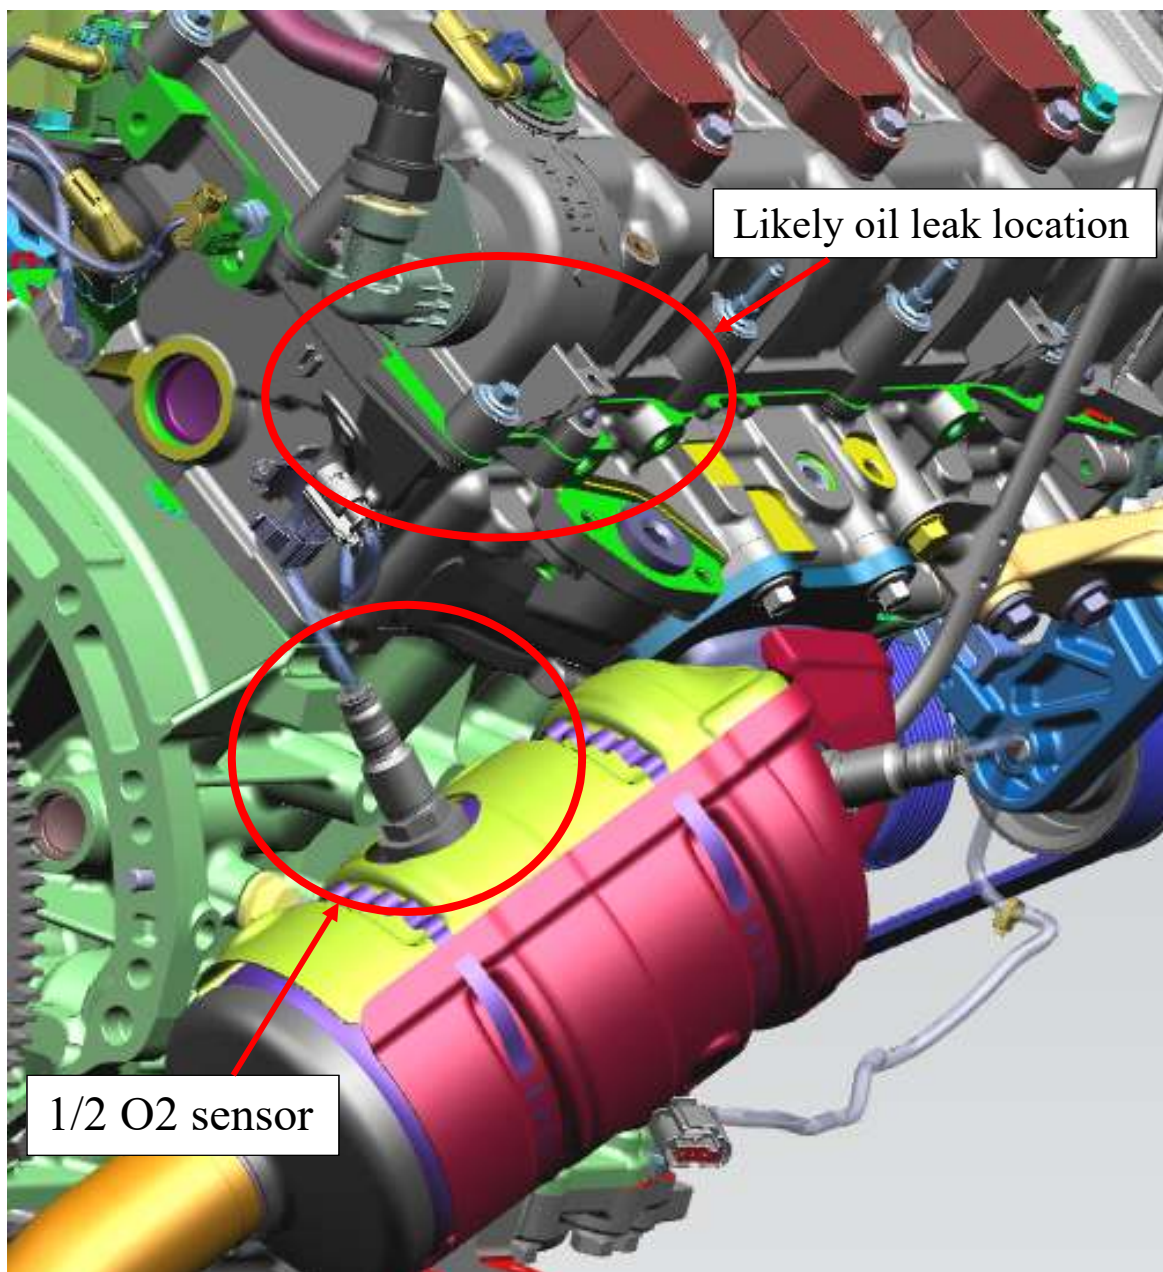
**Symptom/Vehicle Issue:** Customer's complaint may include a MIL-on with one or more of the following DTCs (Active, Pending, or Stored) in the PCM: P0133, P0137, P0171, P0300, P2096. The root cause could be due to oil leaking from Bank 1 valve cover seal on to the 1/2 (Bank 1 downstream) O2 sensor. This can adversely affect the 1/2 O2 sensor signal reading and lead to listed DTCs. Before performing normal diagnostic routines for the above codes, check for the condition listed above.

**Discussion:** Inspect the 1/2 O2 sensor for signs of oil on top of the sensor. If oil is found, replace the 1/2 O2 sensor and inspect Bank 1 valve cover for signs of leakage. If leakage found, repair the valve cover leak as necessary.
