## STAR ONLINE PUBLICATION

**Case Number:** S2008000131 - Rev. C

**Symptom/Vehicle Issue:** U11E9 Lost Communication With AGS (Active Grille Shutter), Malfunction Indicator Lamp (MIL) Illuminated

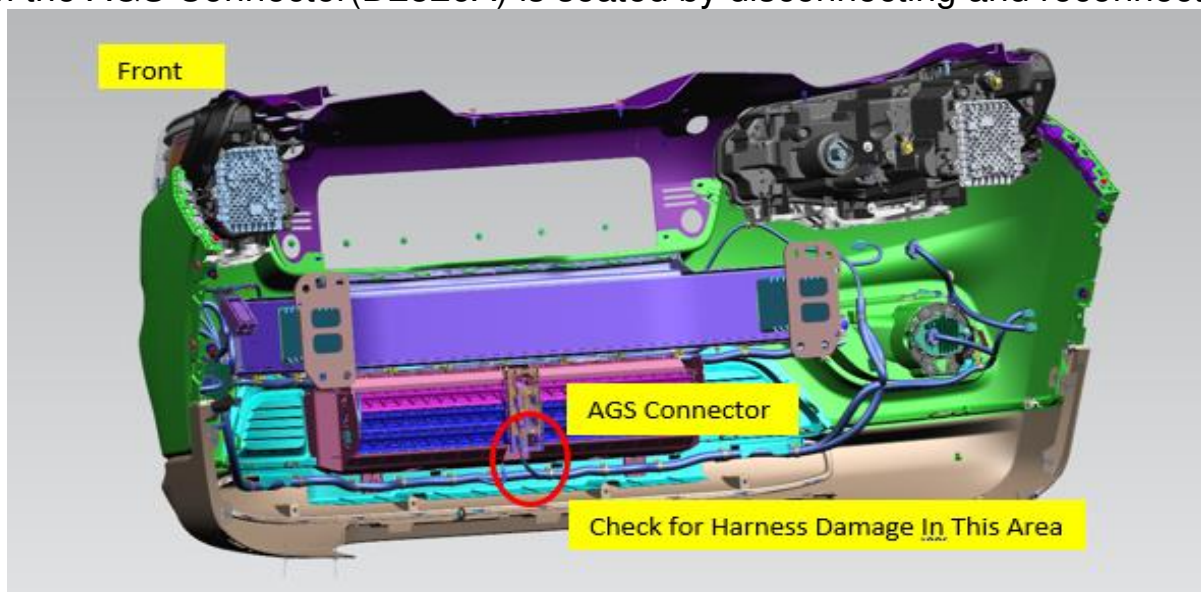
**Diagnosis:** Scan the vehicle for DTC's. If DTC U11E9 – Lost Communication with AGS is active or stored a wiring concern likely exist. Before replacing the AGS, inspect the wiring harness for signs of damage. Small cuts or nicks in the wiring harness have been found by engineering. Including circuits A940B, D511A, Z985BB. You should also confirm the AGS Connector(D2826A) is seated by disconnecting and reconnecting it.

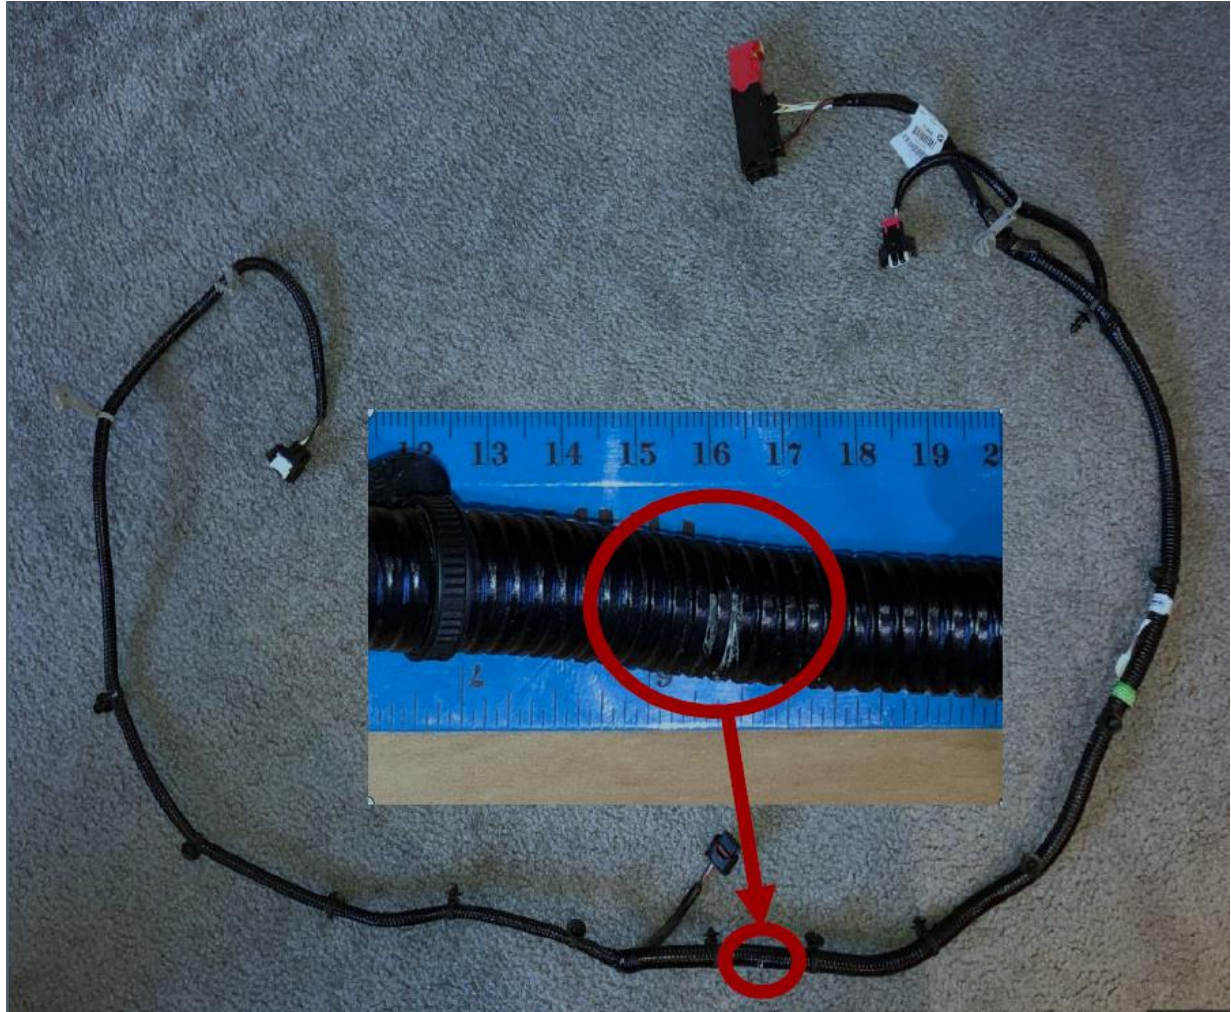
**Damaged AGS Wiring Harness**

**Repair:** Use wiring kit 68396618AB to repair the fascia wiring harness or replace the harness if standard repair methods cannot be applied.

It is also advised to inspect the AGS connector for corrosion. If corrosion is present inside the AGS connector, the AGS connector and AGS will need to be replaced.
