## STAR ONLINE PUBLICATION

**Case Number:** S2108000076

**Symptom/Vehicle Issue:** CEL Check Engine Lamp On, DTC P00F9 Supercharger-Turbocharger Outlet Pressure Sensor Range Performance

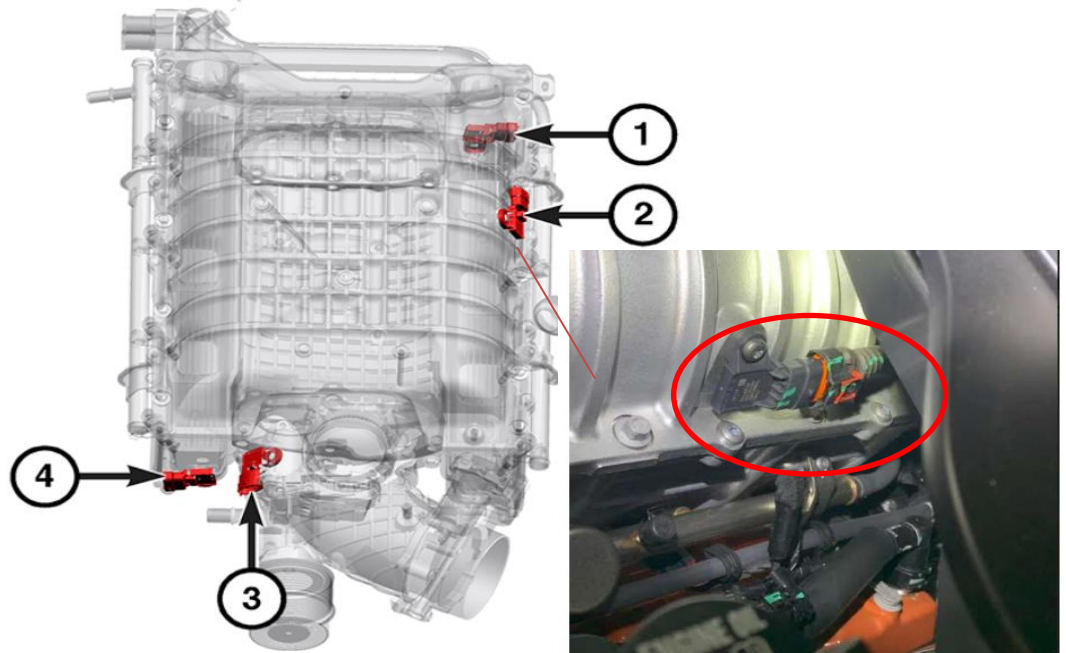
Intake TMAP Sensors

**Customer Complaint/Technician Observation:** Owner complains the CEL lamp is on. Technician observed PCM DTC P00F9 – Supercharger/Turbocharger Outlet Pressure Sensor Range Performance.

**Repair Procedure:** Inspect the # 2 Outlet TMAP Sensor position and secure the connector as needed. Inspect others to complete, no parts required.
