**NUMBER:** 18-028-14 REV. D

Flash: MIL Illumination - Diagnostic and System Improvements

2014 (DS) Ram Pickup (1500)

**NOTE: This bulletin applies to vehicles equipped with a 3.0L diesel engine (sales code EXF).**

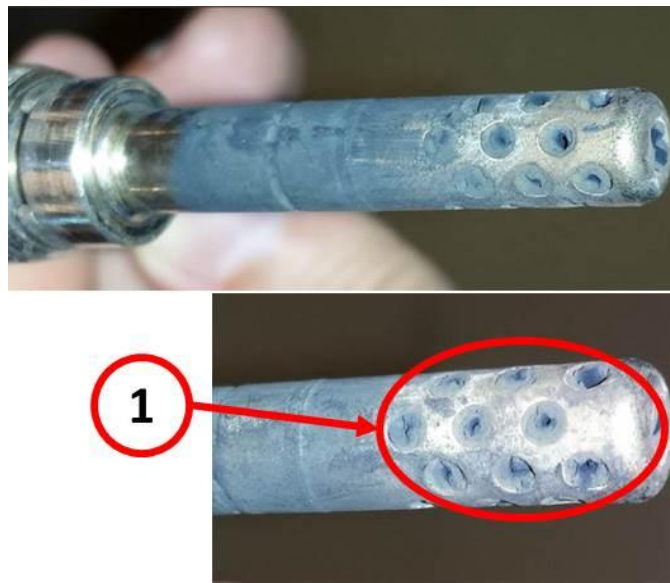
**Fig. 1 EGT Sensor Bank 1 Sensor 2**

10. Replace the O2 sensor. Refer to detailed repair procedures available in DealerCONNECT> TechCONNECT> Service Info Section 14 - Fuel System> Fuel Injection, Diesel> Sensor, Oxygen> Removal/Installation. Proceed to [Step #11](#).
11. Remove the EGT Sensor 1/2 located in the inlet of the Diesel Particulate Filter (DPF)/Diesel Oxidation Catalyst (DOC) assembly. Refer to detailed removal procedures available in DealerCONNECT> TechCONNECT> Service Info Section 11 - Exhaust System> Sensor, Exhaust Temperature> Removal> Exhaust Gas Temperature Sensor 1/2.
12. Inspect the sensor body and probe for any signs of damage or excessive soot. Refer to ([Fig. 1](#)).

1 - Excessive soot blocking sensor ports.

- 
13. Was excessive soot found on the sensor?
    - a. Yes>>> Proceed to [Step #14](#).
    - b. No>>> Proceed to [Step #15](#).
  14. Using shop air set to a maximum of 80 psi, clean all excessive soot from the sensor probe.

15. Using a suitable multi-meter with appropriate test probes, test the resistance between the sensor connector terminals 1 and 2. With the sensor at room temperature, 65-75 °F (18-25 °C), the resistance should measure between 200 and 240 ohms.
