## STAR ONLINE PUBLICATION

**Case Number:** S1918000008 Rev. B

**Release Date:** June 2021

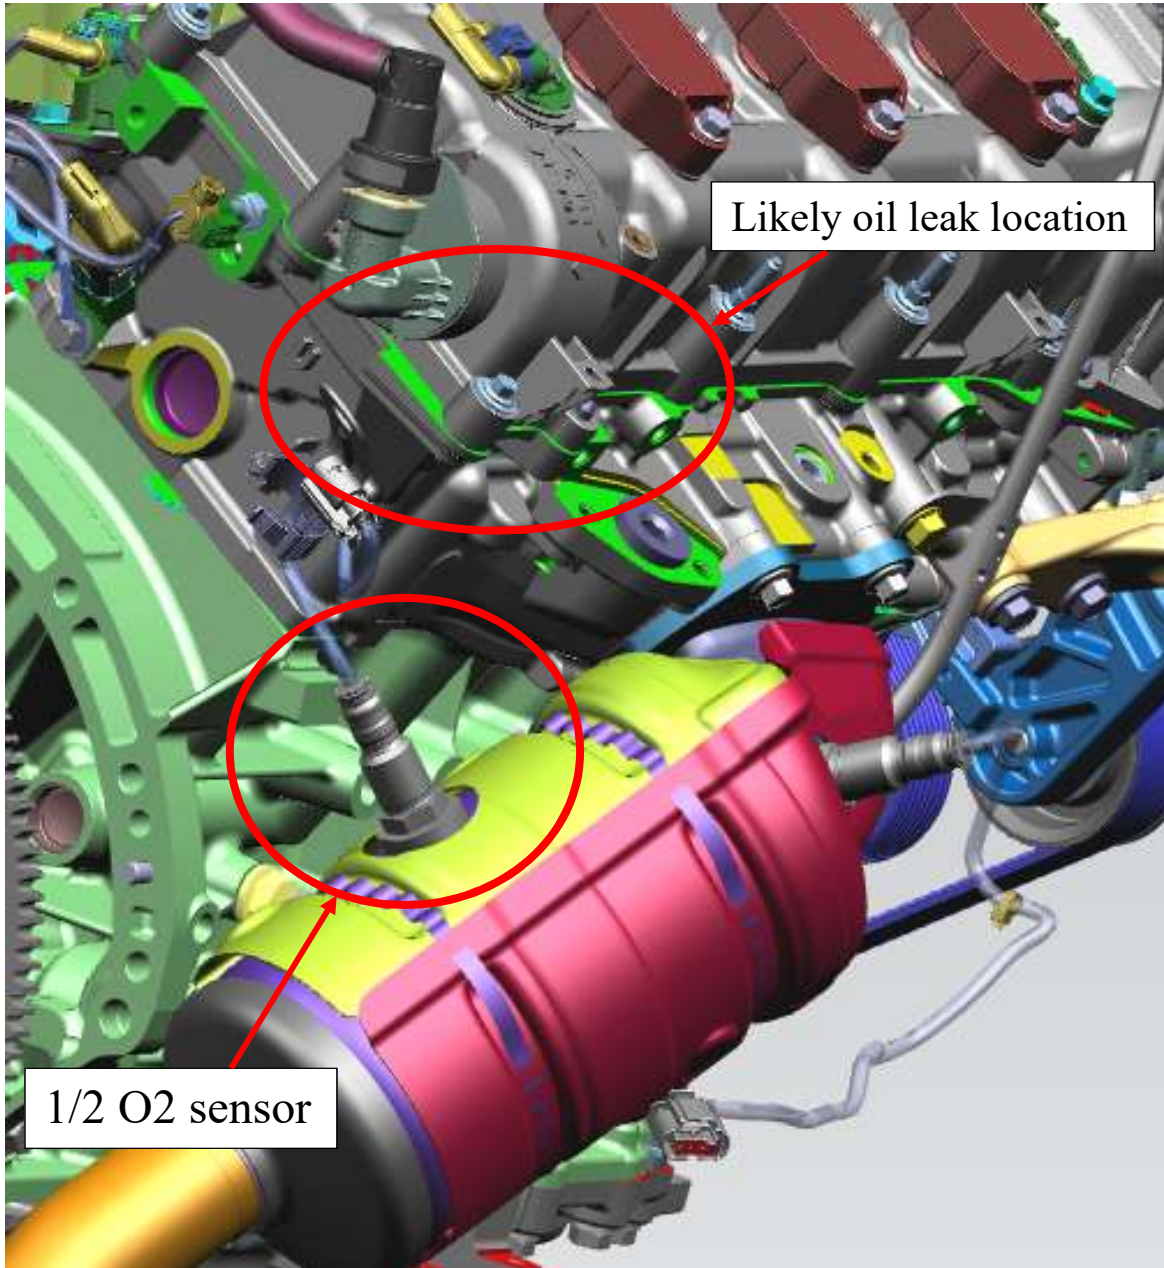
**Symptom/Vehicle Issue:** Customer's complaint may include a MIL-on with one or more of the following DTCs (Active, Pending, or Stored) in the PCM: P0133, P0137, P0171, P0300, P2096. The root cause could be due to oil leaking from Bank 1 valve cover seal on to the 1/2 (Bank 1 downstream) O2 sensor. This can adversely affect the 1/2 O2 sensor signal reading and lead to listed DTCs. Before performing normal diagnostic routines for the above codes, check for the condition listed above.

**Discussion:** Inspect the 1/2 O2 sensor for signs of oil on top of the sensor. If oil is found, replace the 1/2 O2 sensor and inspect Bank 1 valve cover for signs of leakage. If leakage found, repair the valve cover leak as necessary.
