**NUMBER:** 18-015-15

Malfunction Indicator Lamp (MIL) Illumination And/Or Intermittent No Crank No Start

2014-2015 (DS)

Ram 1500

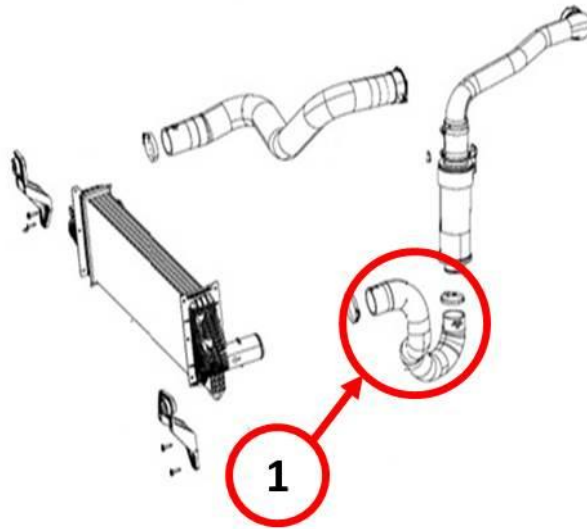
**Fig. 2 CAC System**

1 - Lower CAC hose.

13. Inspect for and drain any accumulated water from the CAC hose. Dry using shop air.
14. Was excessive moisture found in the lower CAC tube?
  - a. Yes>>> Proceed to [Step #15](#).

12. Loosen the clamps and remove the lower CAC hose from between the CAC and resonator. See ([Fig. 2](#)).
