# Technical Service Bulletin

AIR BAG WARNING WITH DTC B1126:13 OR B1127:13

Bulletin No.: 08-002/22

2020-2022 CX-30 with VINS lower than 3MVDM\*\*\*\*\*430409 (produced before June 8, 2022)

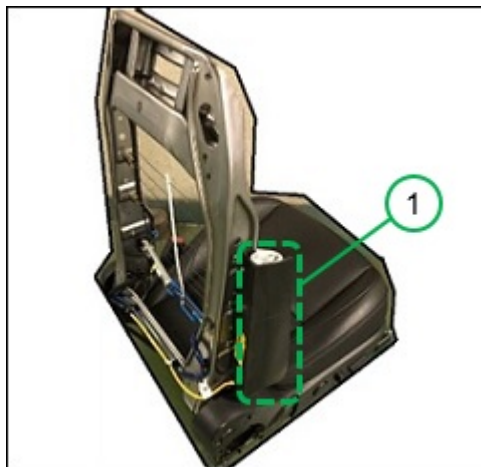
- When the driver or passenger moves, a load is applied to the seat back and the load may cause displacement of the mating terminals in the side air bag module connector, resulting in insufficient contact and higher resistance.
- The DTC detection level is too sensitive.

1. Verify the customer concern.
2. **[For 2020-2022 CX30 with VINs lower than 3MVDM\*\*\*\*\*414338 (produced before Feb. 27, 2022)]** Replace the affected side of the side air bag module(s) (1) with modified one(s) according to instructions on MGSS.
  - US/Canada spec: (SIDE AIR BAG MODULE REMOVAL/INSTALLATION [TWO-STEP DEPLOYMENT CONTROL SYSTEM - US/CANADA SPEC.]).

- Mexico spec: (SIDE AIR BAG MODULE REMOVAL/INSTALLATION [STANDARD DEPLOYMENT CONTROL SYSTEM - MEXICO SPEC.])
