**NUMBER:** 08-007-17 REV. E

**GROUP:** 08 - Electrical

**DATE:** August 10, 2017

UAS, UCQ, UDQ, UJQ and UAQ Radio Enhancements

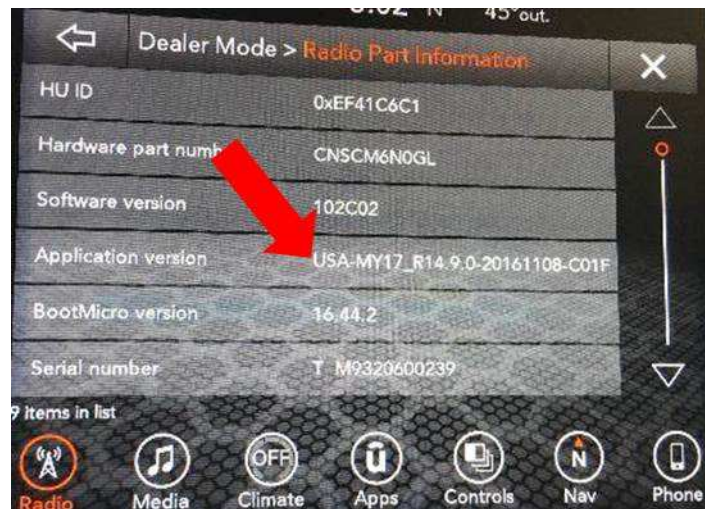
Fig. 1

1. Verify the radio software version. Radio must be in Dealer Mode to verify by following these steps:
  - a. Push and hold the Front Defrost, Driver Temperature Up and Temperature Down buttons simultaneously until the Dealer Mode screen appears (approximately seven seconds). Release buttons.
  - b. Select "Radio Part Information". The software version will be listed next to "Application Version".
2. Is the radio currently at software level 16.11 or higher (Fig. 1) ?
  - YES >>> The radio software is already up to date. This bulletin has been completed.
  - NO >>> The radio software needs to be updated. Back out of Dealer Mode and proceed to [Step 1](#) of the Repair Procedure .

Radio Software Level Screen

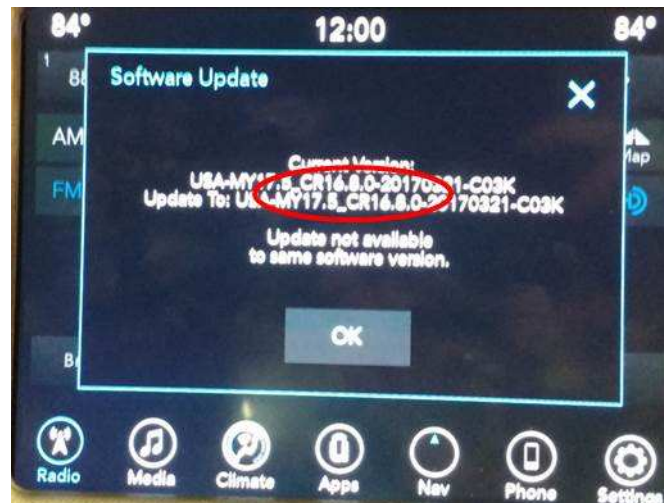
Fig. 9

14. After the update is done the screen will display the software levels again and the message that an update is not available to the same software version (Fig. 9) .

**Software Levels After Radio Restart Screen** (The figure is for reference only, actual software levels will be 16.11)
