**This bulletin supersedes Technical Service Bulletin (TSB) 08-068-22, date of issue March 26, 2022, which should be removed from your files. All revisions are highlighted with **\*\*asterisks\*\*** and include an updated build date.**

Global Telematics Box Module (TBM2) Firmware Over The Air Software Version Updates

2022 (MP) Jeep Compass

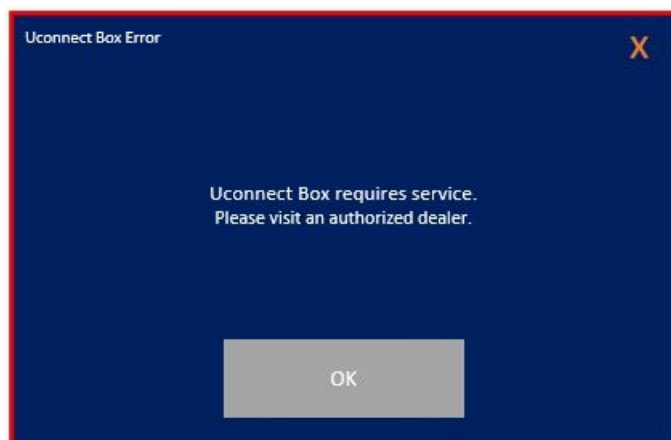
**Fig. 1**  
**Error Message**

- Message displayed on the radio screen, "Uconnect Box requires service. Please visit an authorized dealer." (Fig. 1) .

Upon further investigation, a technician may find the following Diagnostic Trouble Code (DTC) has been set:

- B1570-93 - USB Communication-No Operation.

Vehicles sold in the U.S. and Canada can now receive software updates “over-the-air”. Updates to software will occur in a phased roll-out. The software is updated through a built-in cellular modem in the vehicle. Customers will see a notification on their radio screen when new software is available for their radio (Fig. 2) . The owner will have the option to update the radio or schedule the update for later. There is not an option to decline the update indefinitely, the update must be performed.
