## SERVICE BULLETIN

**APPLICABILITY:** 2019-21MY Forester

**NUMBER:** 03-89-22R

**SUBJECT:** DTC B280B VDC Brake Fluid Pressure

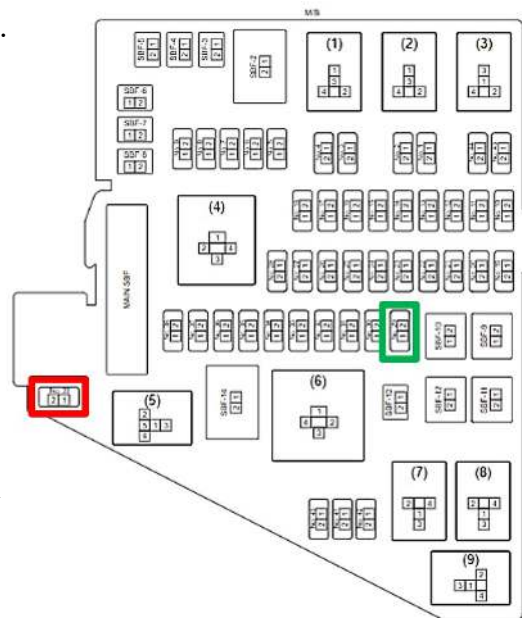
After reprogramming the VDC system, the Auto Headlight Leveler Control will be in the fail-safe status. Follow the procedure outlined below for proper initialization. If this procedure is not followed, the steering responsive headlights and headlamp leveling features may become temporarily unavailable.

- A. Confirm the vehicle is parked on a flat and level surface.
- B. Turn the ignition switch to the “OFF” position.
- C. Remove the 30 Amp transport fuse from the #29 (**GREEN**) position of the main fuse box located under the hood.
- D. Insert the removed fuse into the #39 (**RED**) position and switch the ignition switch to the “ON” position.
- E. Wait at least three seconds, then turn the ignition switch to the “OFF” position.
- F. Return the fuse to the original position (#29).
- G. Start the engine and run for at least three seconds. Using the Subaru Select Monitor (SSM), clear any fault codes that might have been set during the procedures listed above.
- H. Perform a function test of ALL the operations of the headlight system.
